Buildings 8 & 10

Historic Structure Report

Coltsville National Historical Park
Hartford, Connecticut

2017

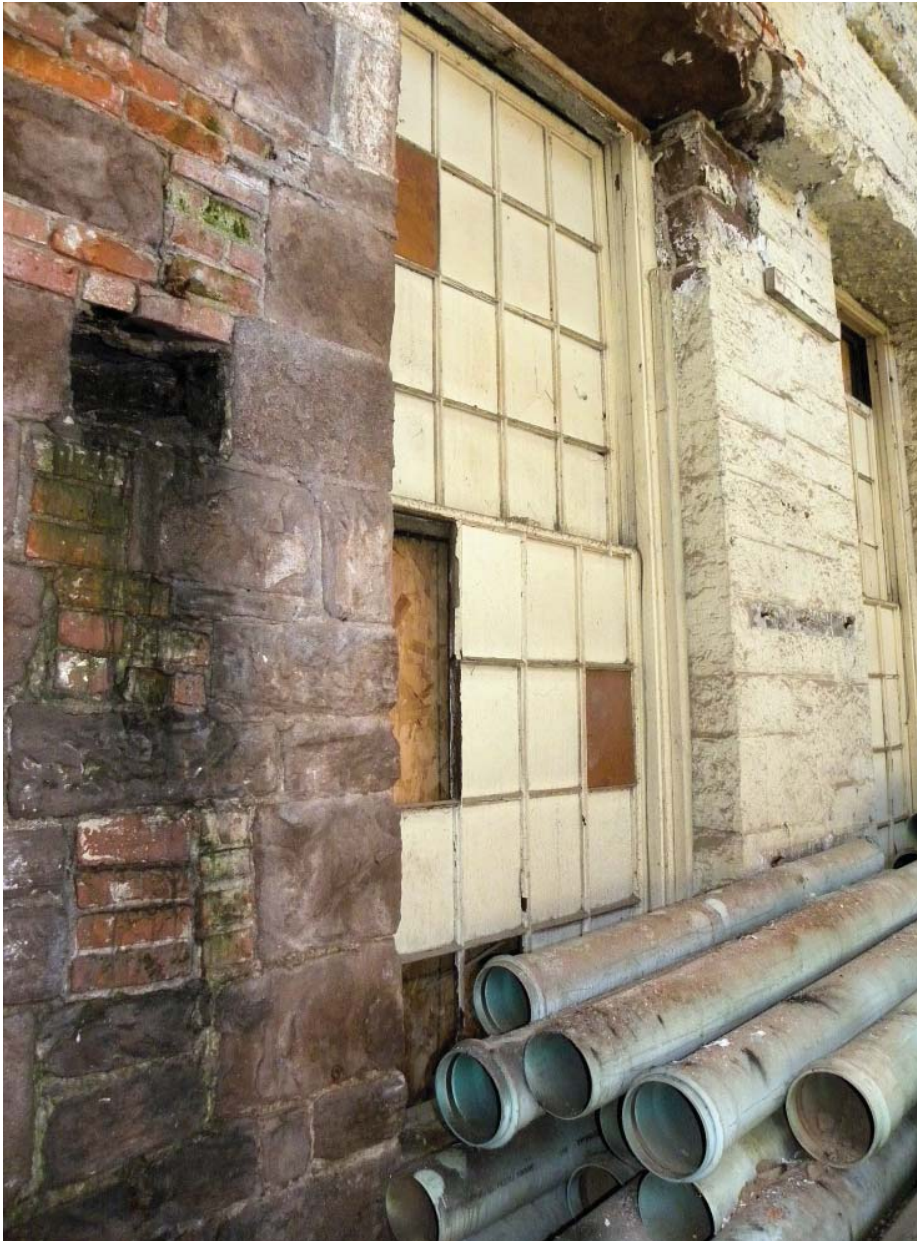
Figure 22. Typical brick patch in brownstone pier, Building 10.

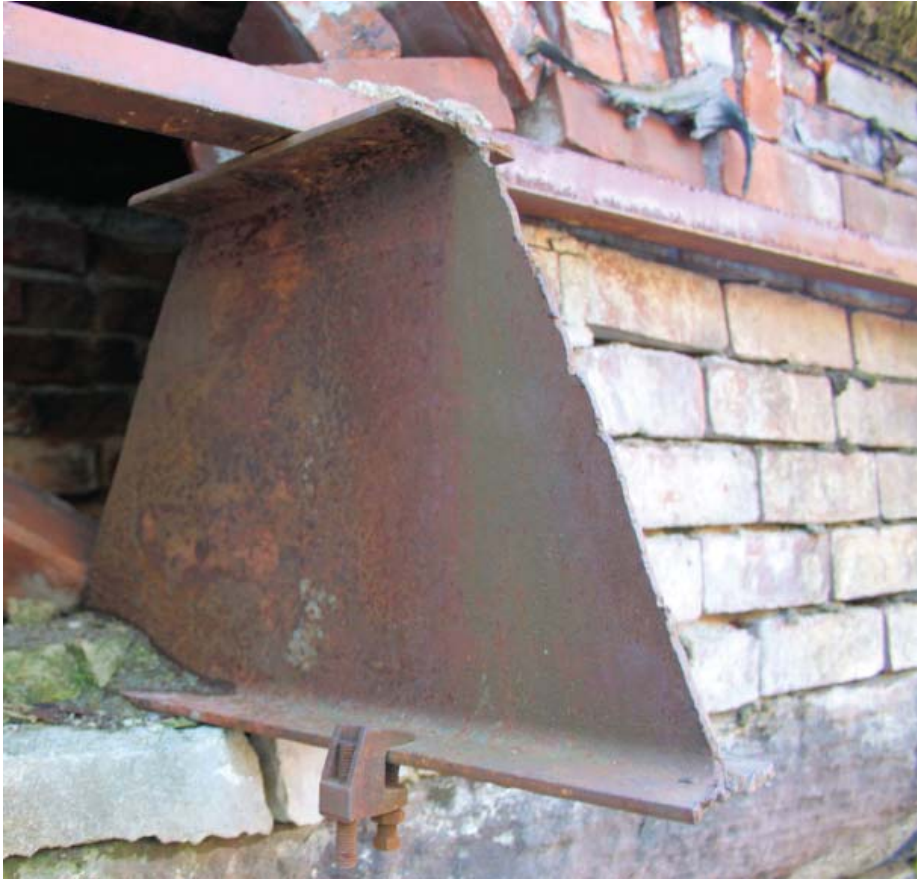
Figure 44. Typical cut end of roof beam, Building 10, east elevation.

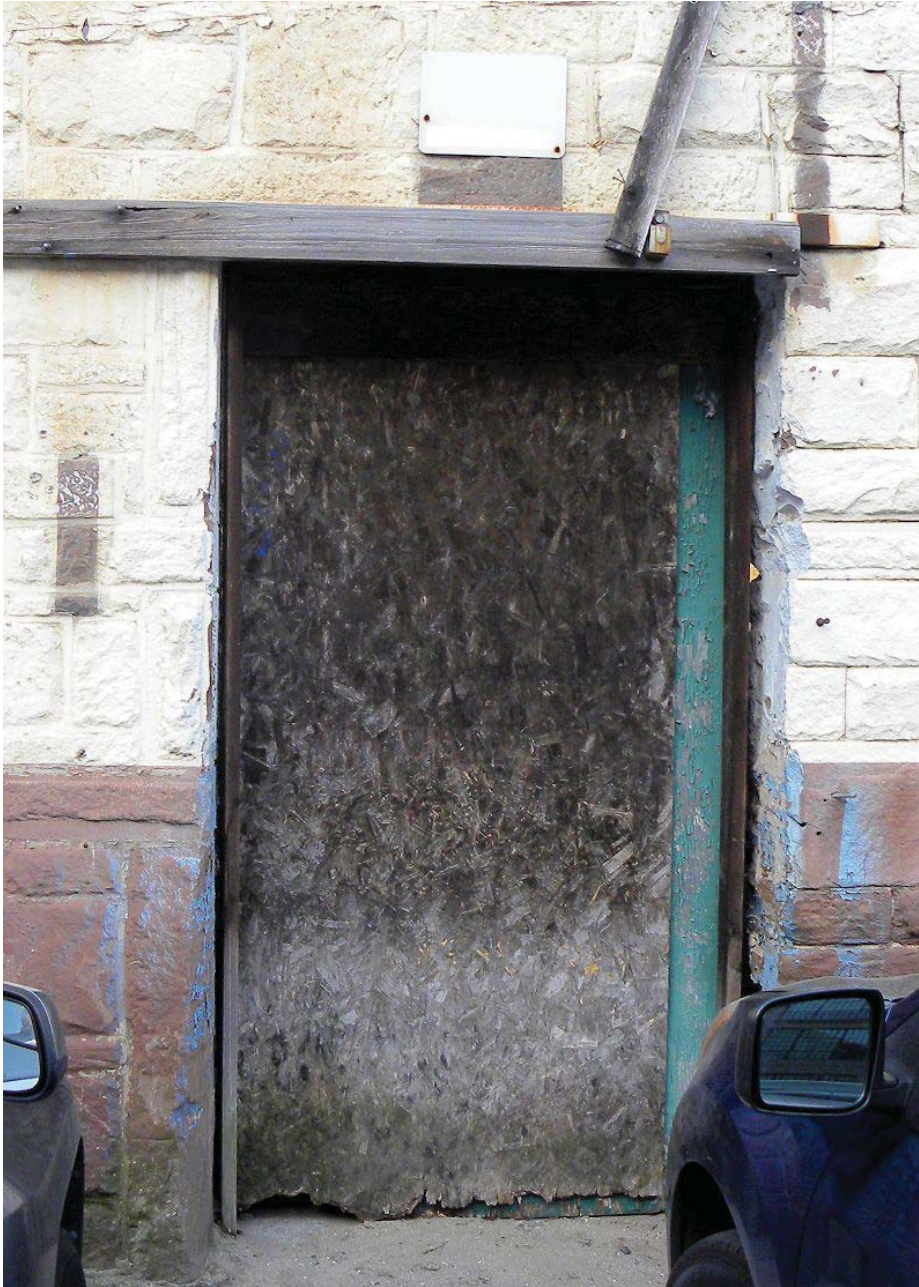
Figure 45a. Enlarged exit doorway cut into original door opening, bay 19, Building 10, east elevation.

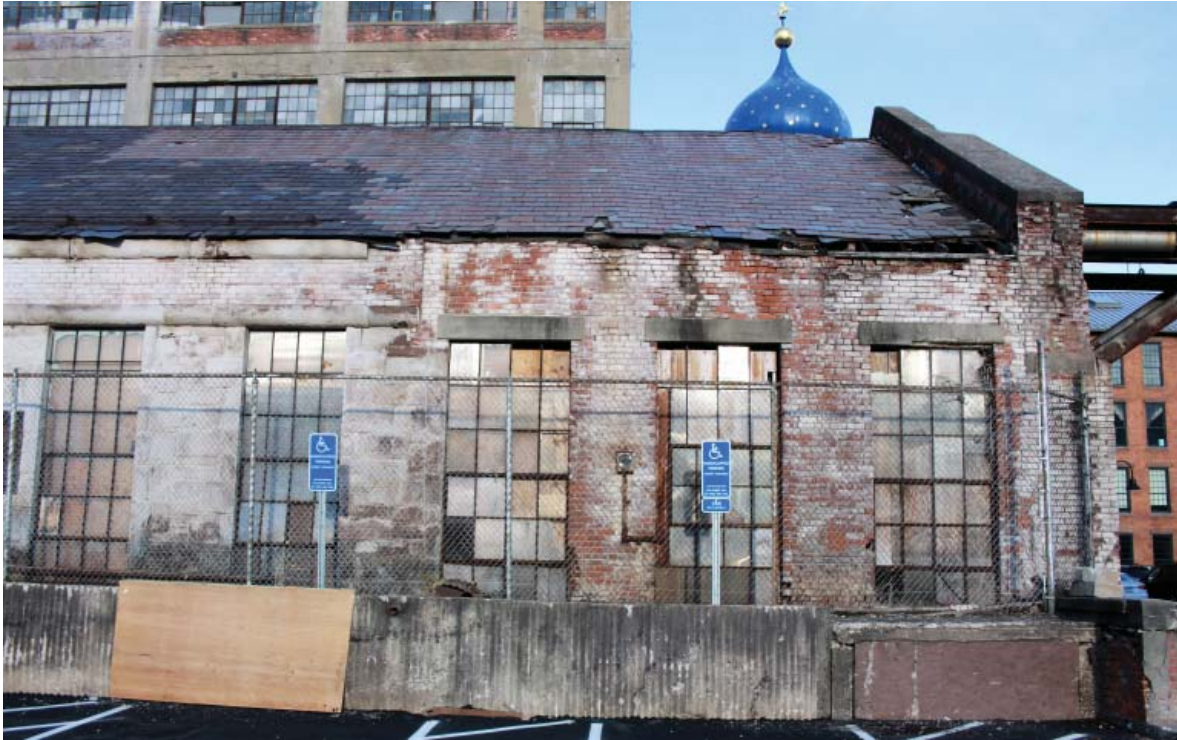
Figure 61. Mismatched slate at the south end of Building 8, west roof slope. *In the foreground is the raised, early 20th century steam tunnel. The last three window bays are not original. Note missing slates at eave and water damage to masonry below.*

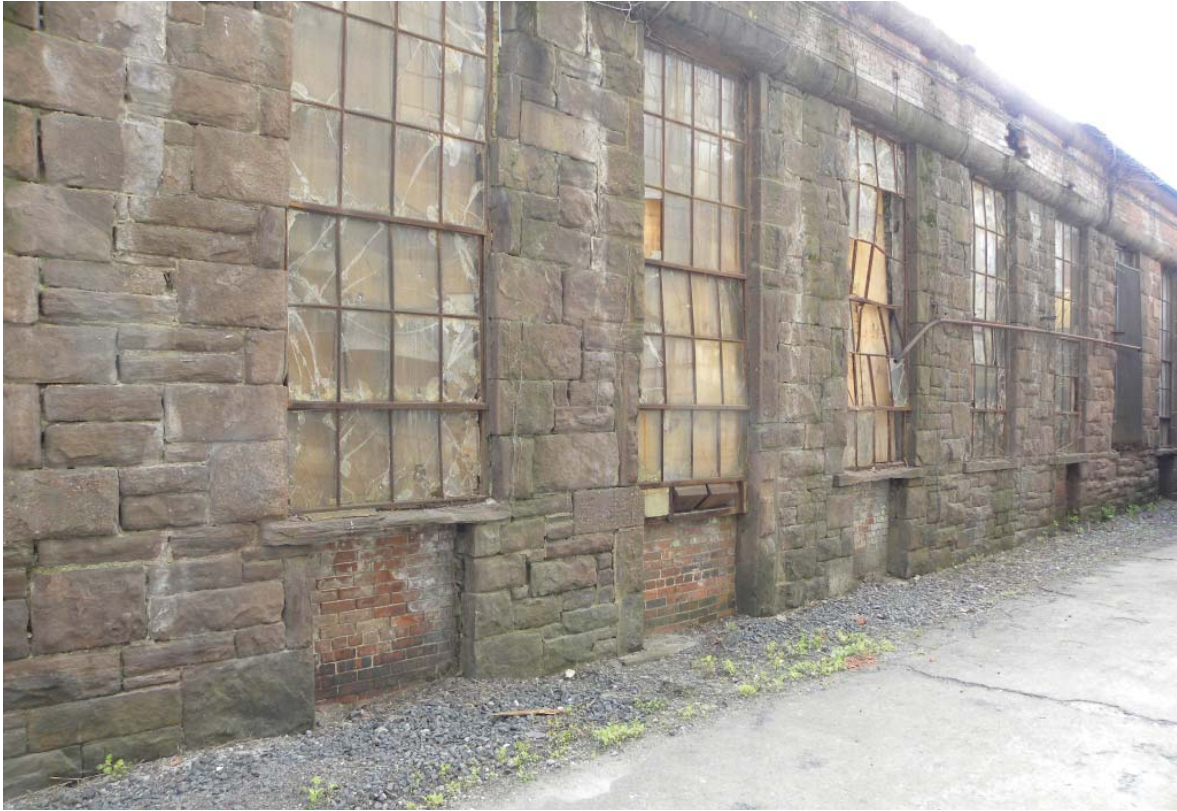
Figure 62a. Building 8, partial east elevation, looking north. *The second window has been created in an original doorway as evident in the shape of the jamb units. This explains the sequence of three brick panels, instead of an alternation between brick and brownstone, below the window sills.*

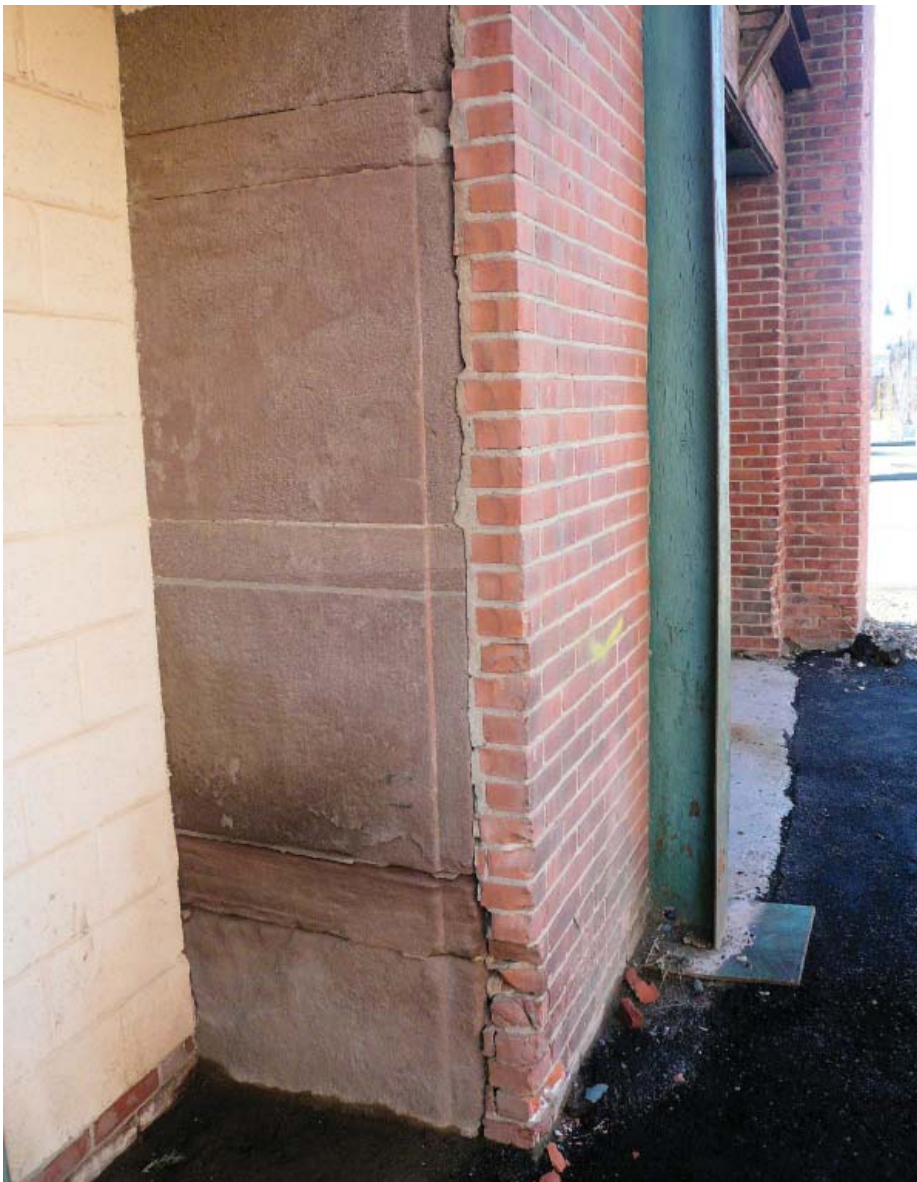
Figure 66. Recent brick veneer, Building 10.

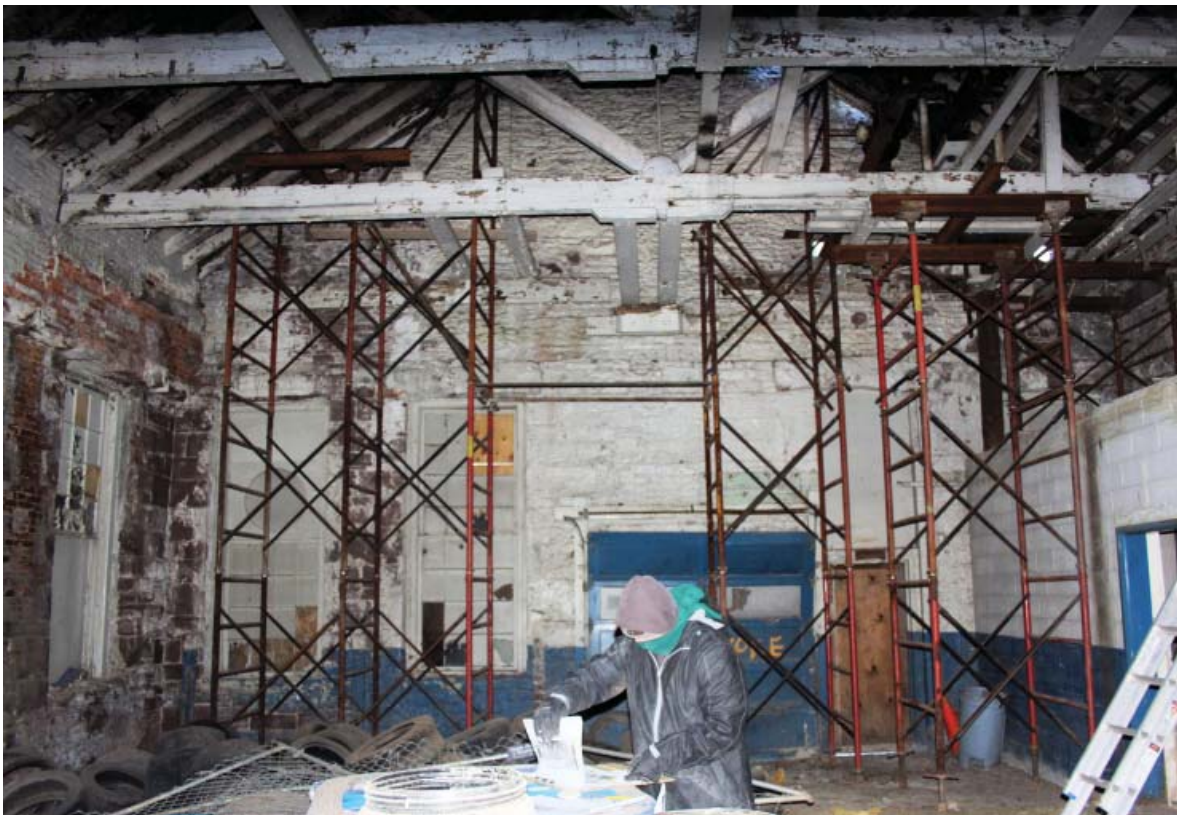
Figure 69. Building 10, interior looking south. *Note concrete block enclosure of electrical closet at right.*

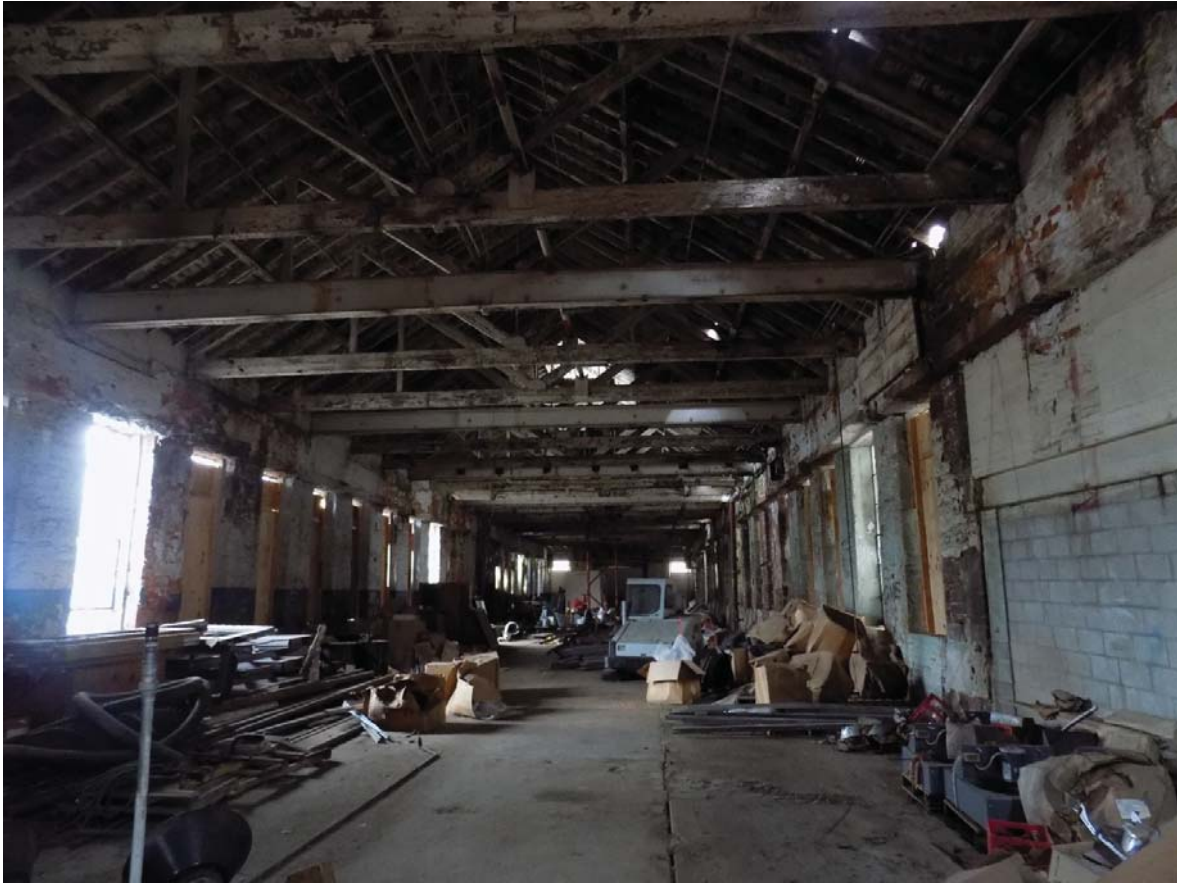
Figure 70. Scaffold support, Building 8, interior looking north. *Note concrete block infill of later doorway at bays 19 & 20 at right.*

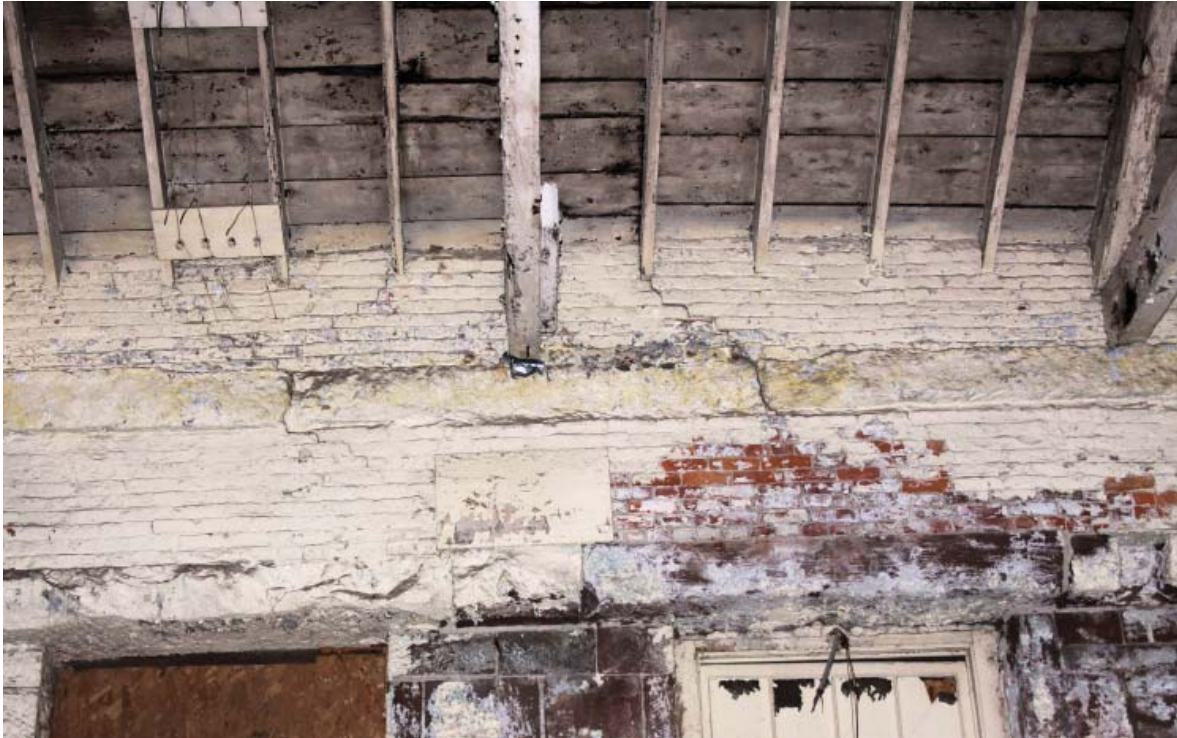
Figure 71. Representative view of upper part of interior walls, Building 10, east wall. *Note remnants of an early electrical power distribution system at left.*

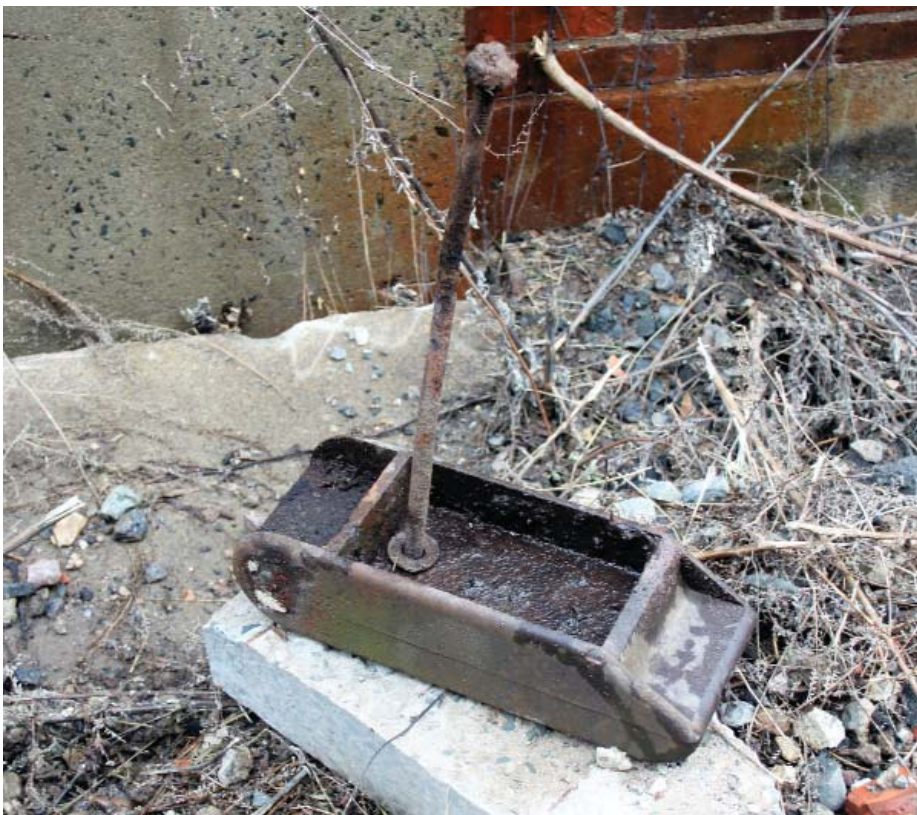
Figure 72. An unseated truss shoe.

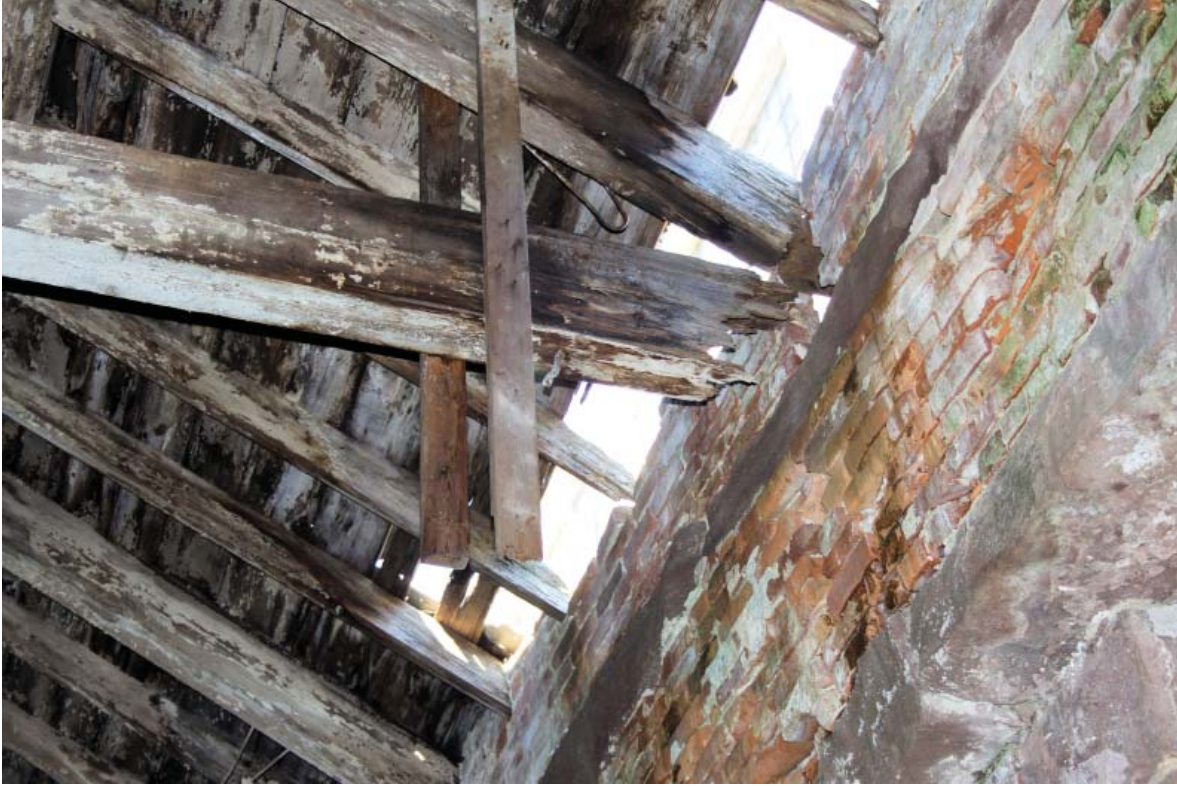
Figure 75. Missing roofing boards, east elevation, Building 8. *Note metal straps joining the decayed truss elements.*

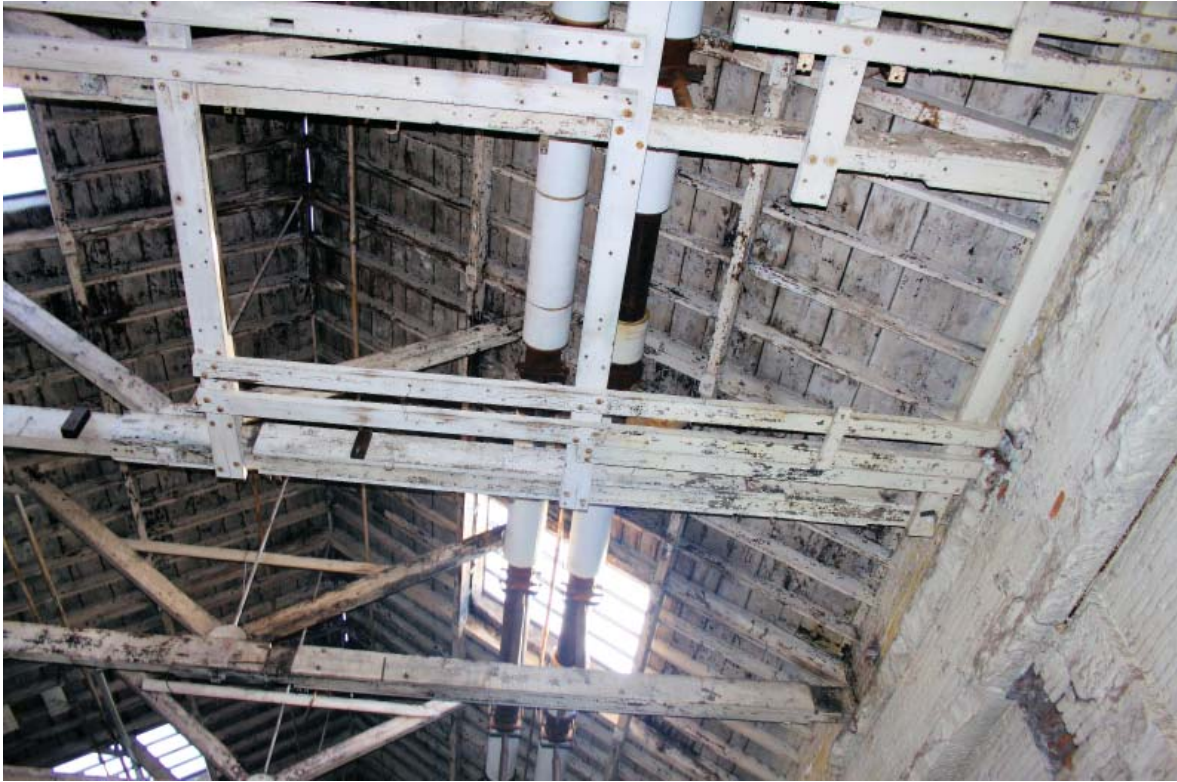
Figure 77. Skylights and steam piping at Building 10. *Note daylight where ridge flashing is missing and ancillary framing below trusses.*
