BRAINARD AIRPORT  
Hartford, Connecticut

# HISTORIC RESOURCES INVENTORY BUILDING AND STRUCTURES

1. BUILDING NAME (Common) (Historic)  
Dept. of Aeronautics Headquarters Same

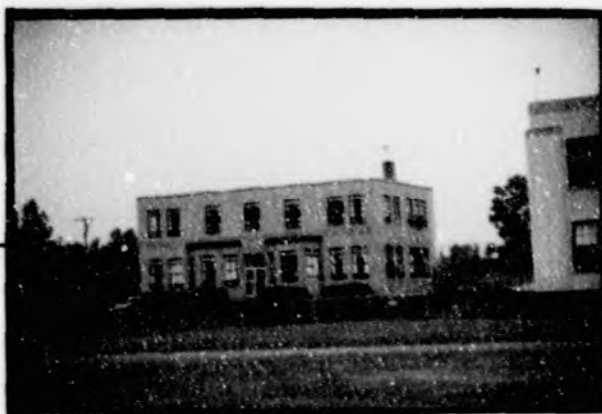
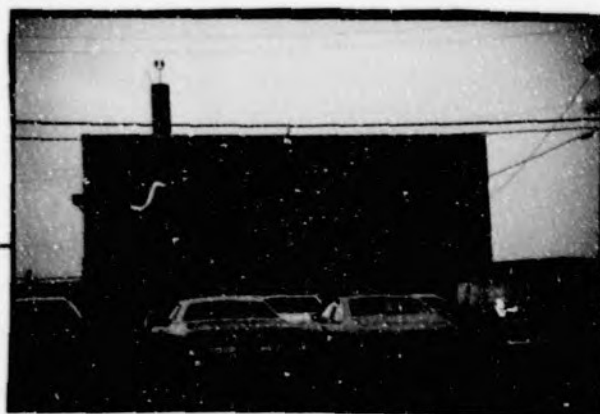
facade &amp; west elevation

12. CONDITION (Structural) (Exterior)  
☐ Excellent ☒ Good ☐ Fair ☐ Deteriorated ☐ Excellent ☒ Good ☐ Fair ☐ Deteriorated

13. INTEGRITY (Location) WHEN? (Alterations) IF YES, EXPLAIN  
☒ On original site ☐ Moved ☒ Yes ☐ No roof was raised from one story to two stories

The Headquarters Building is a two-story buff-colored brick structure with a flat roof. It is seven bays long with a centered entrance. This has a double glass and aluminum door with transom and brick soldier course lintel. The east-facing facade has two one-story bay windows. Fenestration consists of fixed and hopper-type windows with brick soldier course lintels. Second story windows are slightly shorter. There is a brick soldier belt course just below the second story window sills.

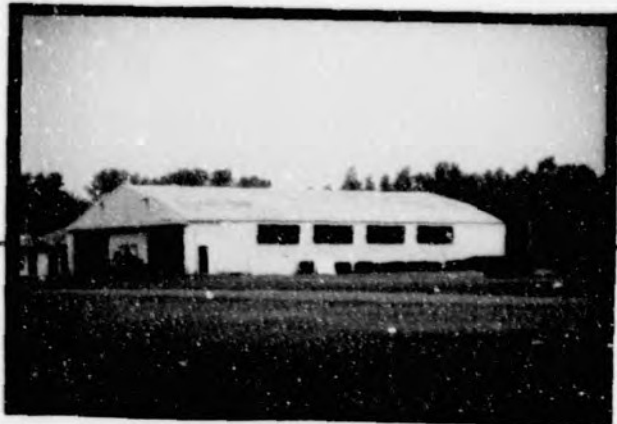
PHOTOGRAPHER M. Grabowicz DATE 6/24/85 VIEW northeast corner NEGATIVE ON FILE CHC NAME M. Grabowicz DATE 7/85 ORGANIZATION Connecticut Historical Commission ADDRESS 59 South Prospect Street, Hartford, CT 06106

12. CONDITION (Structural)

DESCRIPTION (Continued)	17 OTHER NOTABLE FEATURES OF BUILDING OR SITE (interior and/or exterior)		
	<p>This is a 1½ story rectangular brick structure with a very flat gambrel roof which is covered with tin. On the south elevation, there is a wood paneled door with four lights and segmental arched brick radiating voussoirs comprised of two courses of brick headers. The east-facing facade has three overhead, metal garage doors. The north elevation has brick piers between four sets of four (3x3) rectangular fixed and casement metal sash industrial-type windows. There is a newer, non-descript addition on the south elevation.</p>		
SIGNIFICANCE	18 ARCHITECT		BUILDER
	19 HISTORICAL OR ARCHITECTURAL IMPORTANCE <p>This structure is significant because it is one of the earliest hangers at the airport which currently remains on state property.</p>		
SOURCES

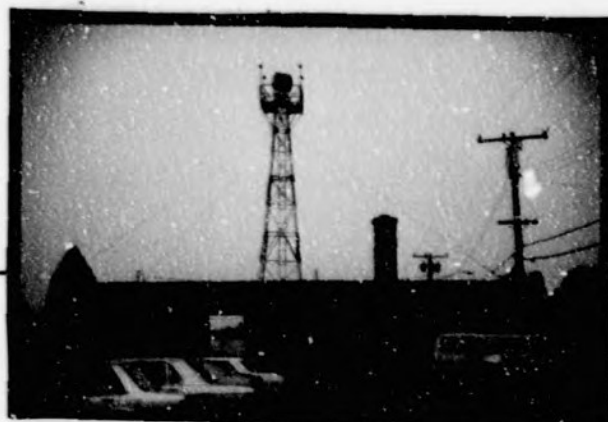
VIEW  
north elevation

☒ needs repointing

This is a one-story rectangular brick structure with a flat roof. It has overhead garage doors located on the north and south elevations. Fenestration consists of multipane (4x5) industrial sash-type windows. On the west elevation the windows are located between brick piers.
