Buildings 8 & 10

Historic Structure Report

Coltsville National Historical Park
Hartford, Connecticut

2017

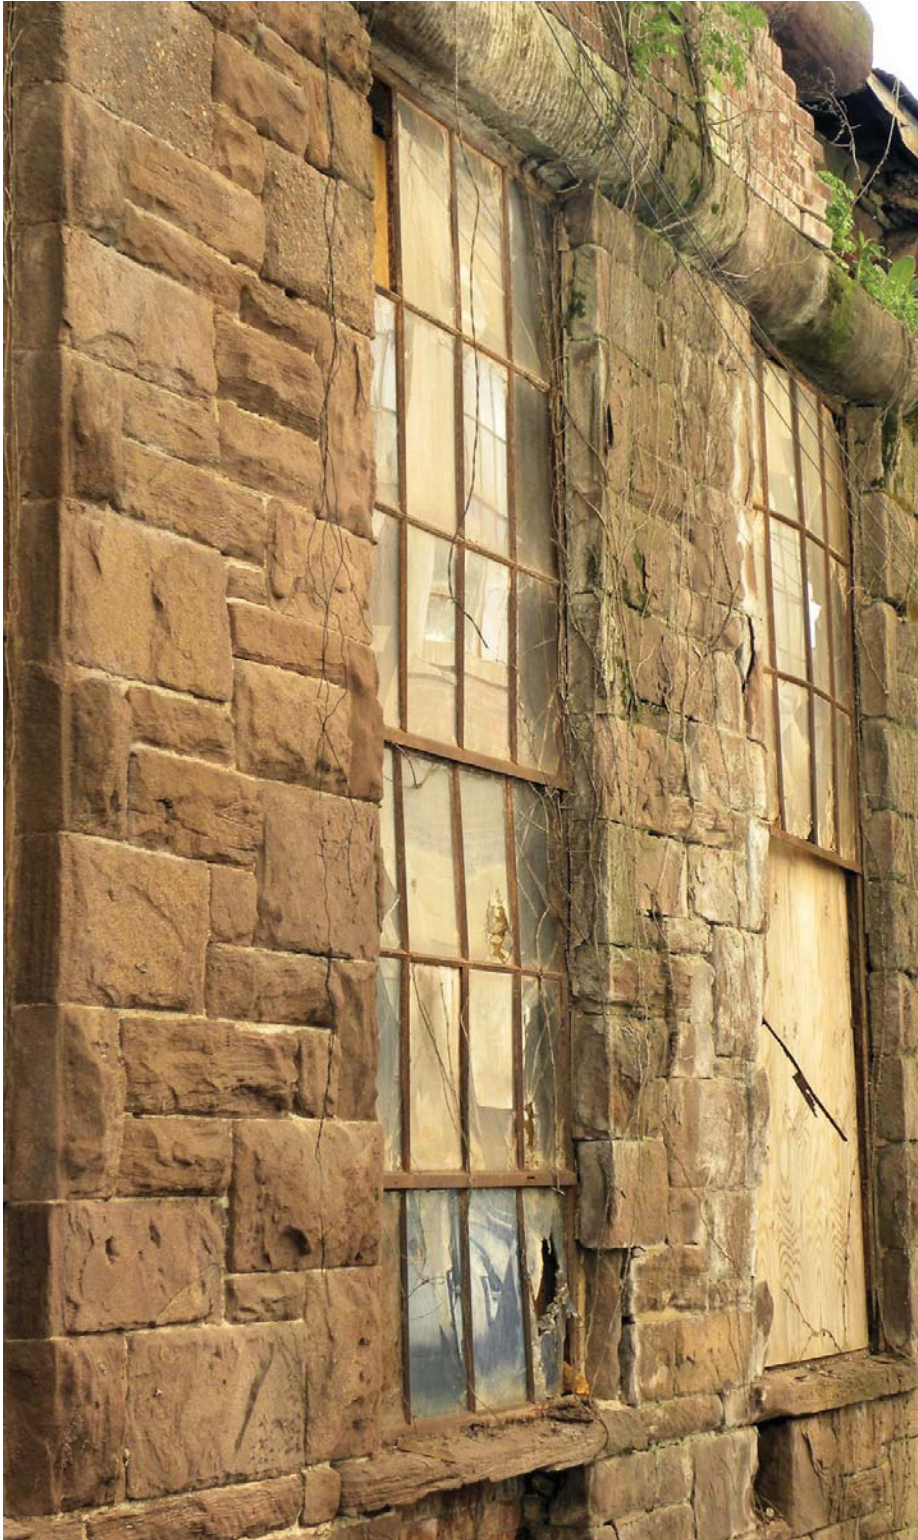
Site observation has revealed that openings in the brownstone masonry had typical details. While the brownstone of the elevations was typically rock-faced, the perimeter of the rock-face of the jamb units was chiseled, and their return in the jamb was smooth. The head units had a semi-bullnose profile curving up from the window heads and were bush hammered as discussed above. See figures 3, 4, 6 and 12. By contrast, the inner face of the same head units projected straight out from the interior wall, and their vertical front edge was rock-faced. See figure 18. The sills were also brownstone. It appears today that they projected only slightly beyond the brick spandrels and even less beyond the brownstone spandrels. They are heavily worn, so projection as well as finish may have been lost. It is likely that they were dressed smooth to aid run-off. See figure 4 and figure 47c below.

Figure 4. Typical masonry window opening treatment, Building 8, east elevation. *The sash is not original.*

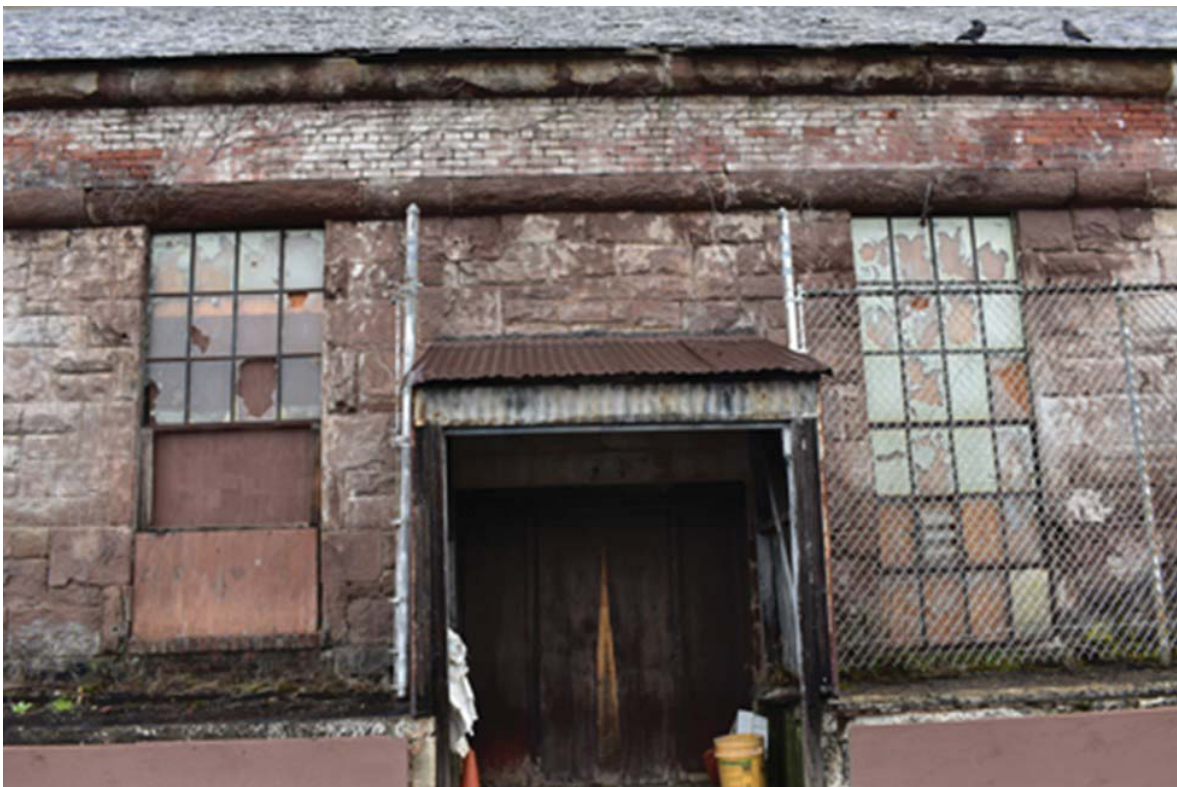
There is, however, a brownstone lintel built into the wall and brownstone fill above it in bay W9 of Building 8. It is hidden under a corrugated shed roof that protects a later, larger doorway with its own concrete lintel. See the plan of the building in Appendix F for the location, and figures 4a and 4b below.

Figure 4a. Exterior of bay W9, Building 8. Note integrated brownstone masonry between the original architrave unit and the later corrugated shed roof below. Photo by J. Woolsey, NPS.

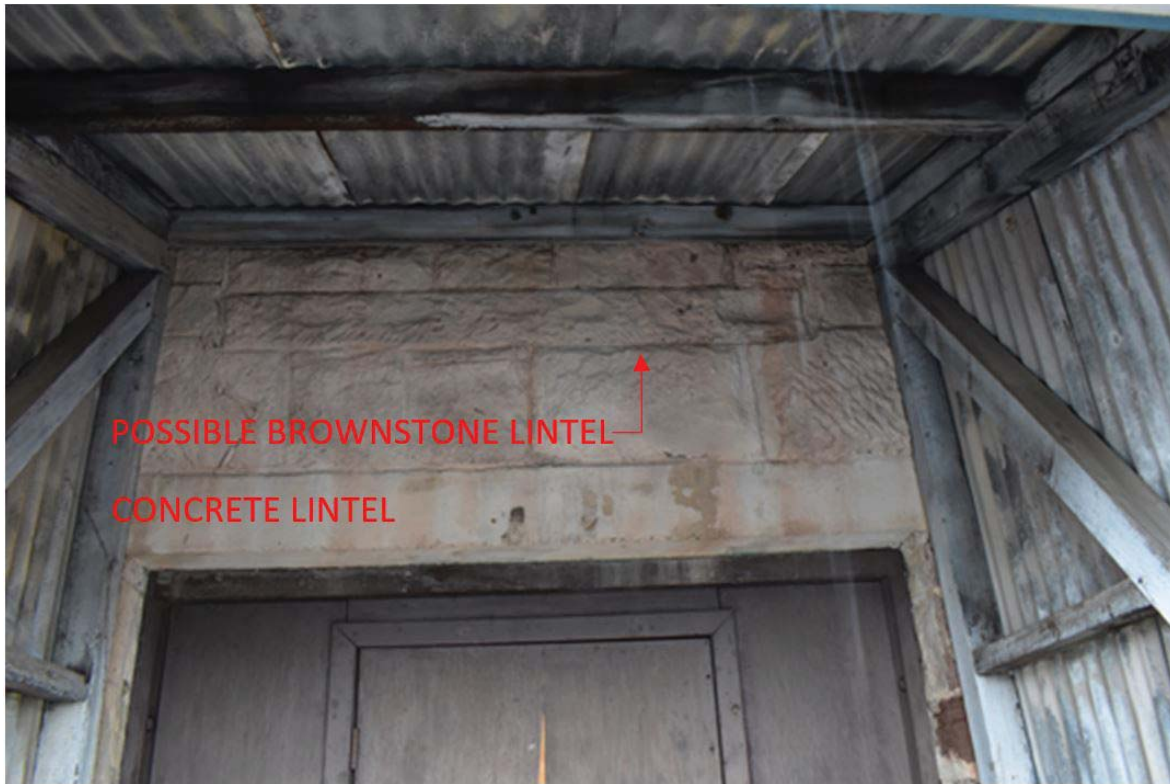
Figure 4b. Brownstone lintel set above later concrete lintel, bay W9, Building 8. *Photo by J. Woolsey, NPS.*

The unit appears to be set at the same height as a typical doorway head and shares similar dimensions but it does not have precisely the same character. It appears to lack the chiseled perimeter of all other doorway surround units. However, the fill above it has the same rock-face finish found in the typical walls into which it blends smoothly. This fill does not have the straight vertical boundaries that might have accompanied a quick infill of an original window opening.

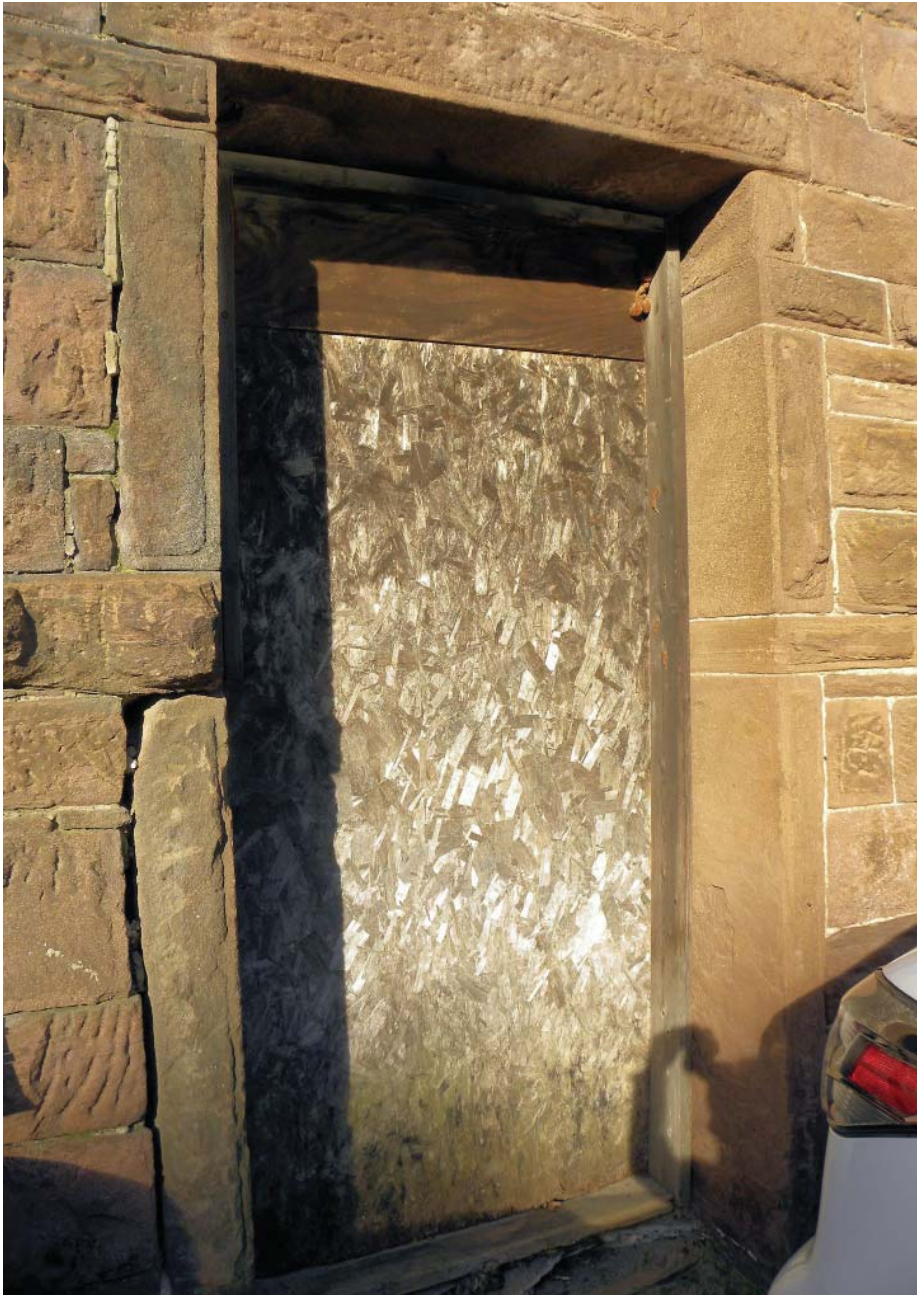
The jambs were detailed with tall, thin upright units alternating with low, narrow, horizontal units. This pattern contrasted with that created by the more evenly matched face dimensions of the rock-faced jambs of the window openings and of most units in the general fields of the walls. However, both window and door jambs units dovetailed into the intervening brownstone piers. See figure 5.

Figure 5. Typical detailing of original doorway surround, Building 10, east elevation.

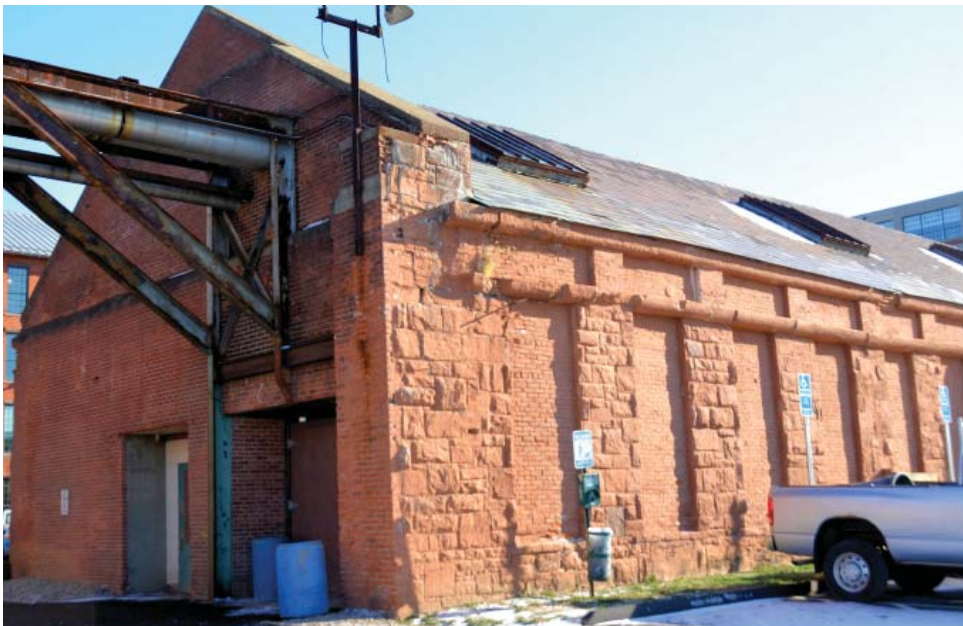
Figure 6. Building 10, northwest corner, showing brownstone architrave and cornice and brick frieze with pilasters.

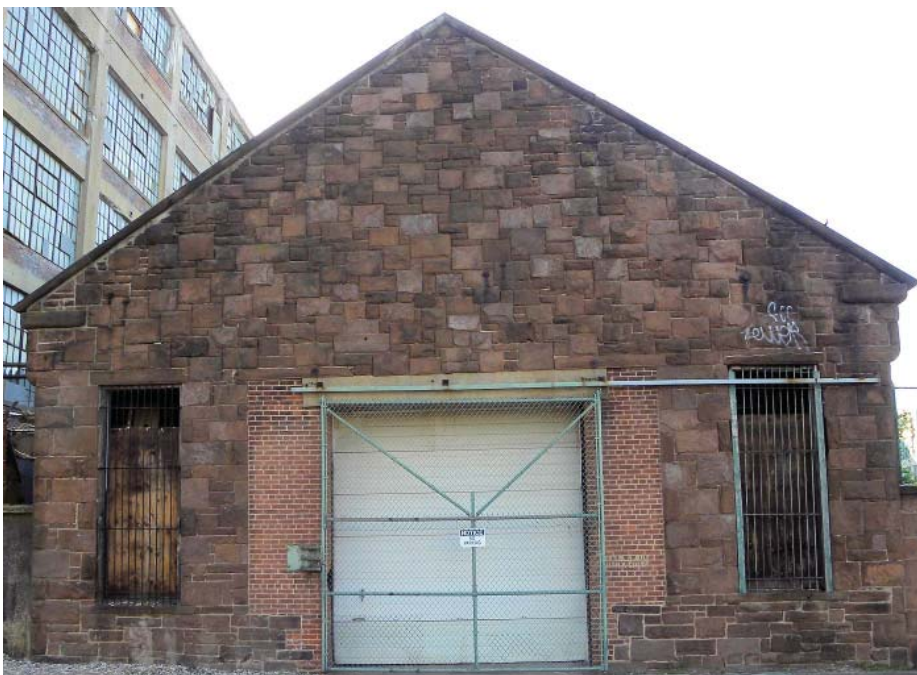
Figure 7b. North facade of Building 8 today.

Figures 7a and b show that the north gable end of Building 8 and the south gable end wall of Building 10 had a raked stone caps. There was also a brownstone return of the cornice at the eave below. They can still be seen. The clarity of these details helps one to discern them in the distant view of the south end of Building 10 (Fig. 2). Stone caps were also shown on an early lithograph but not the returns (Fig. 8). It is reasonable to believe that stone caps were the original material; a few units at the south end of Building 10 that appear to be cast concrete must be later replacements.

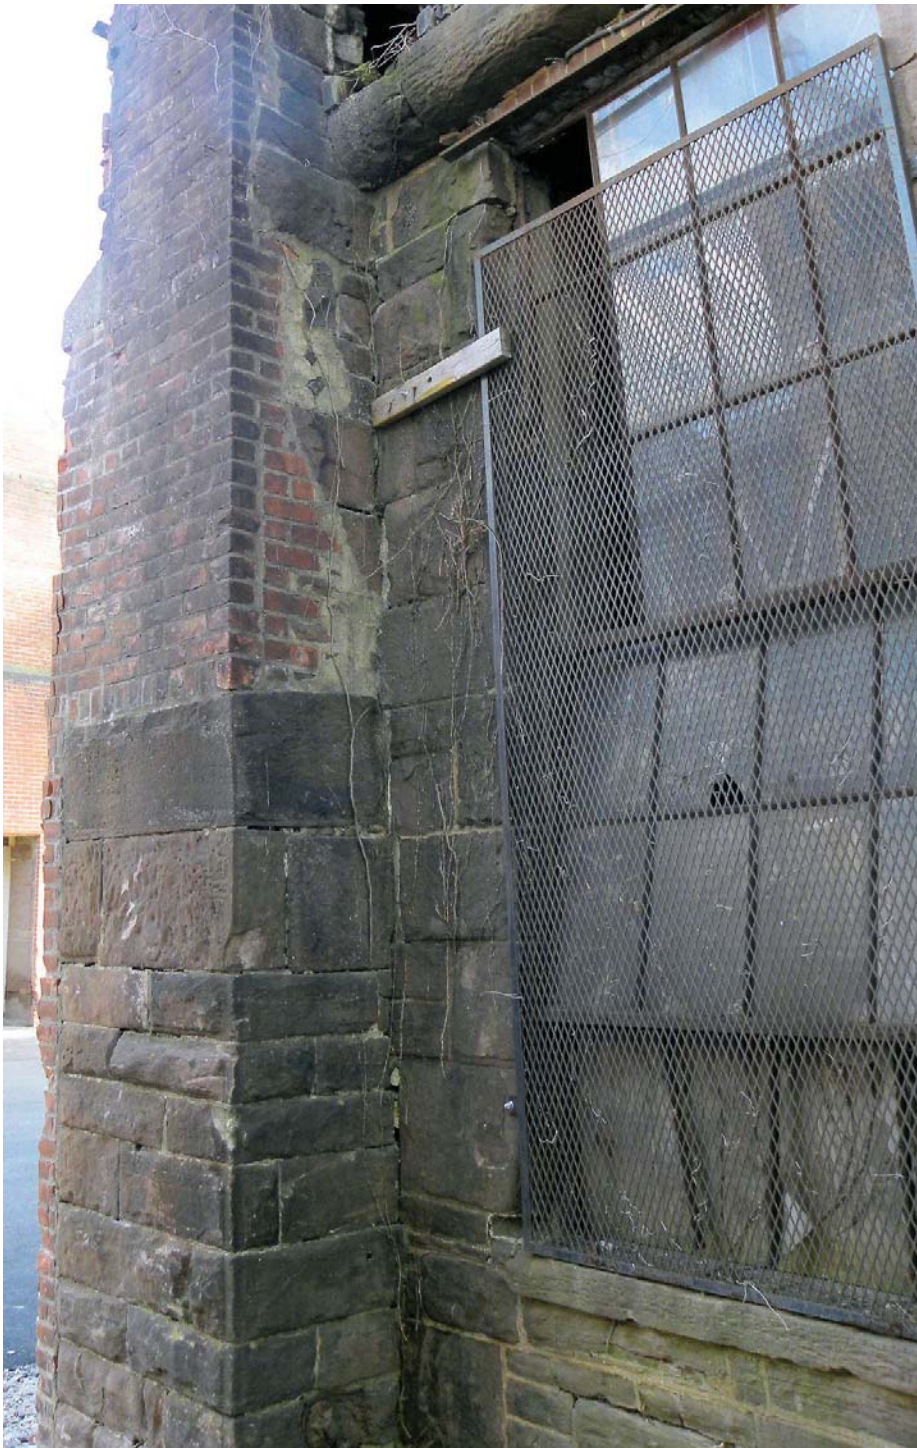
in the 1857 plan (Appendix D, plate 8). The units have the rock face and chiseled perimeter of doorway brownstone units, but in contrast, their returns are also rock faced. See figures 9a and 9b.

Figure 9a. Buttress, originally jamb of entry arch to passage from the north to the south court yards, Building 8, southeast corner.

- (9) Brownstone remnants of arched entries to the original passageway through the spine at the south end of Building 8 and north end of Building 10, east elevations. (Figs. 9a, 9b)

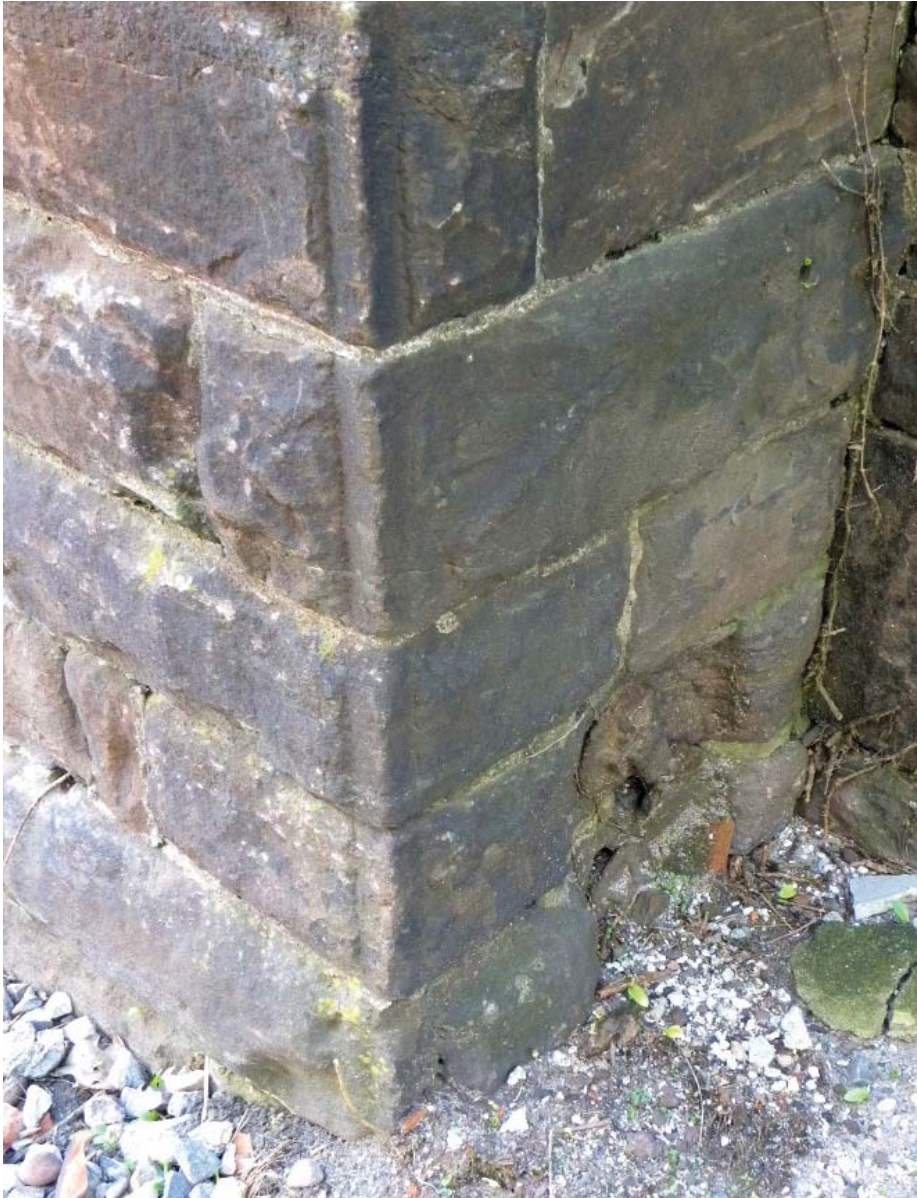
Figure 9b. Detail of jamb shown in Figure 9a.

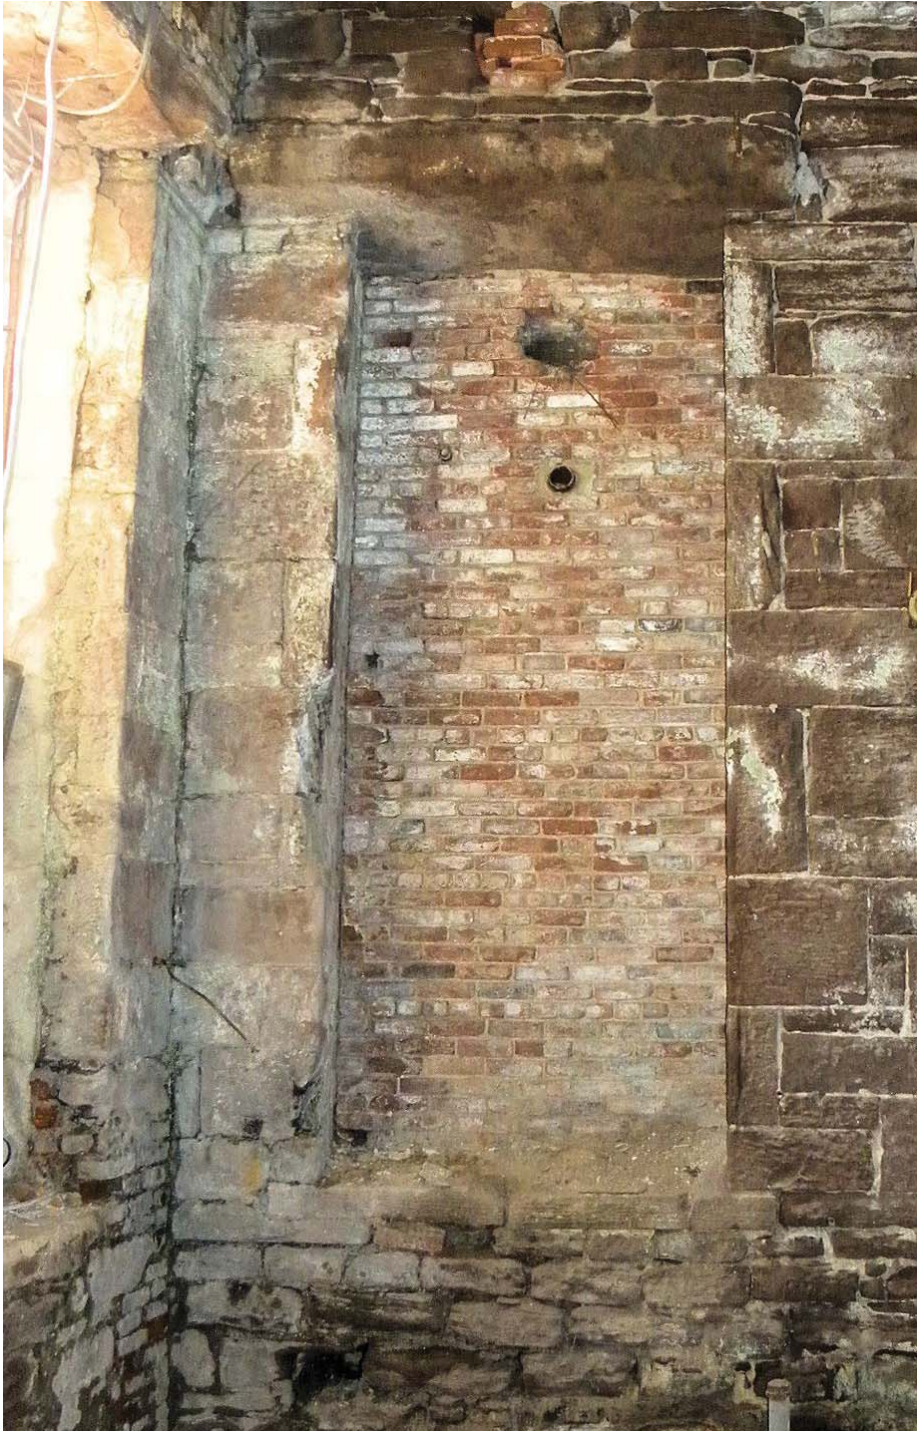
The 1857 plan revealed no obvious need for fenestration in these original brownstone partitions. However, seen from the interior today, the now bricked-in openings at the east end of the wall between Building 8 and the store room suggest otherwise. There were three. Figure 10a shows the most westerly and most distinct from the interior. Two similar bricked-in window openings can be discerned in the eastern half of the north elevation of Building 10.

Figure 10a. Infilled window opening, Building 8, south interior elevation.

The size, shape and elevation of these infilled openings echo the features of a typical original window opening as does the dovetailed detailing of the brownstone jamb units and sills and the relationship of the head to the architrave above. See figures 4 and 6 above. Perhaps the two to the east of the doorway were added early to improve observation of the store room from the 'Inspectors Room' shown at the south end of Building 8 in the 1857 plan (Appendix D, plate 8), but there is no obvious reason for openings between the adjacent 'Tool Room' and the store room, nor for openings between the storeroom and the 'Annealing Room' shown at the north end of Building 10.

- v) Original window openings and their brick fill, south end of Buildings 8, north and south ends of Building 10 (Figs. 10a, 59)
 - b) Heavy timber construction**

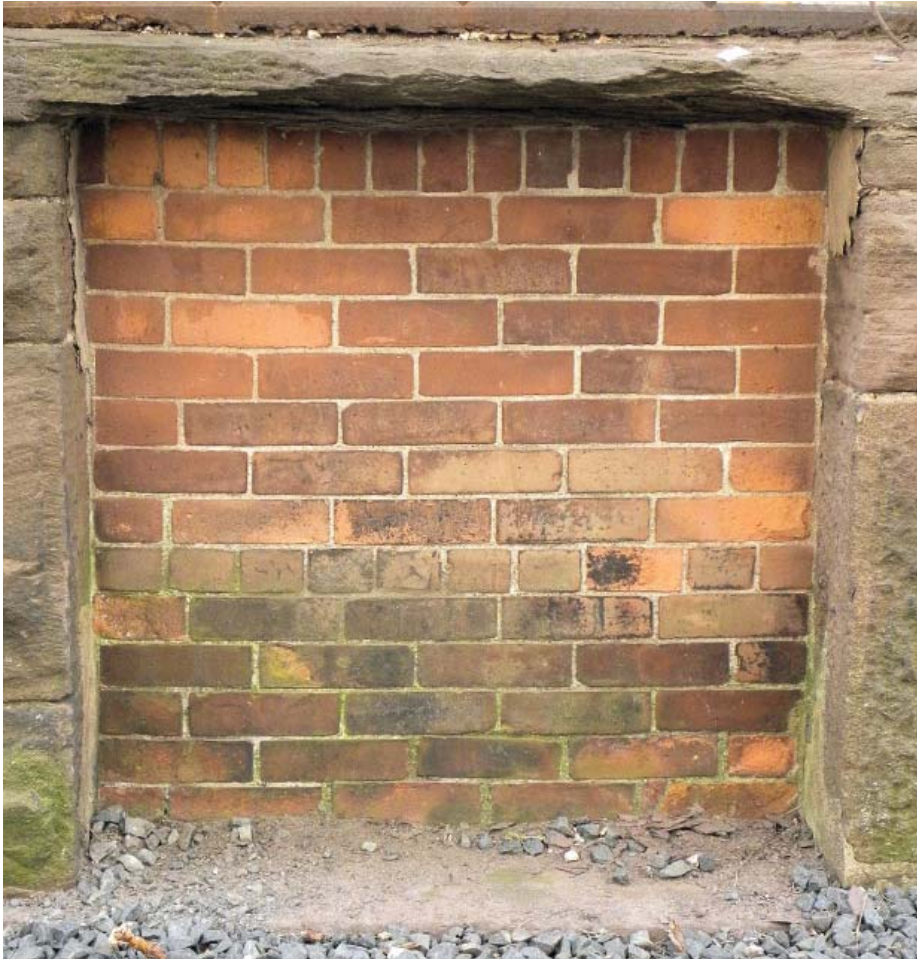
No early photographs captured the construction of the envelope below the window sills. On-site inspection showed that every second spandrel still visible between grade and a sill was brownstone set in the same plane as the pier. These brownstone spandrels alternated with common brick panels which were set back under the sill and laid up in a stretcher or running common bond. See figure 4. However, certain details suggest that they may not be original. The brick never appears to be toothed into the surrounding brownstone masonry, and sometimes the top course is set with sailors not stretchers. See figure 10b.

One or two have a top course of brick fragments. Together these facts suggest that the brick could have been a later infill responding to as-built conditions. Perhaps the brick was installed when the two buildings were no longer used as a forge and a foundry. Mortar analysis showing Portland cement in the mix would establish that they were installed decades after the buildings were constructed, since the EYP site survey found that all non-repair mortar in the brownstone masonry was clearly a lime and sand mix. Further research would be required to establish how the areas with the brick panels were originally detailed, perhaps as vents for make-up air or cooling, or as hatches for delivery of coal for the hearths and furnaces.

Figure 10b. Brick spandrel with sailor top course, Building 8, east elevation.

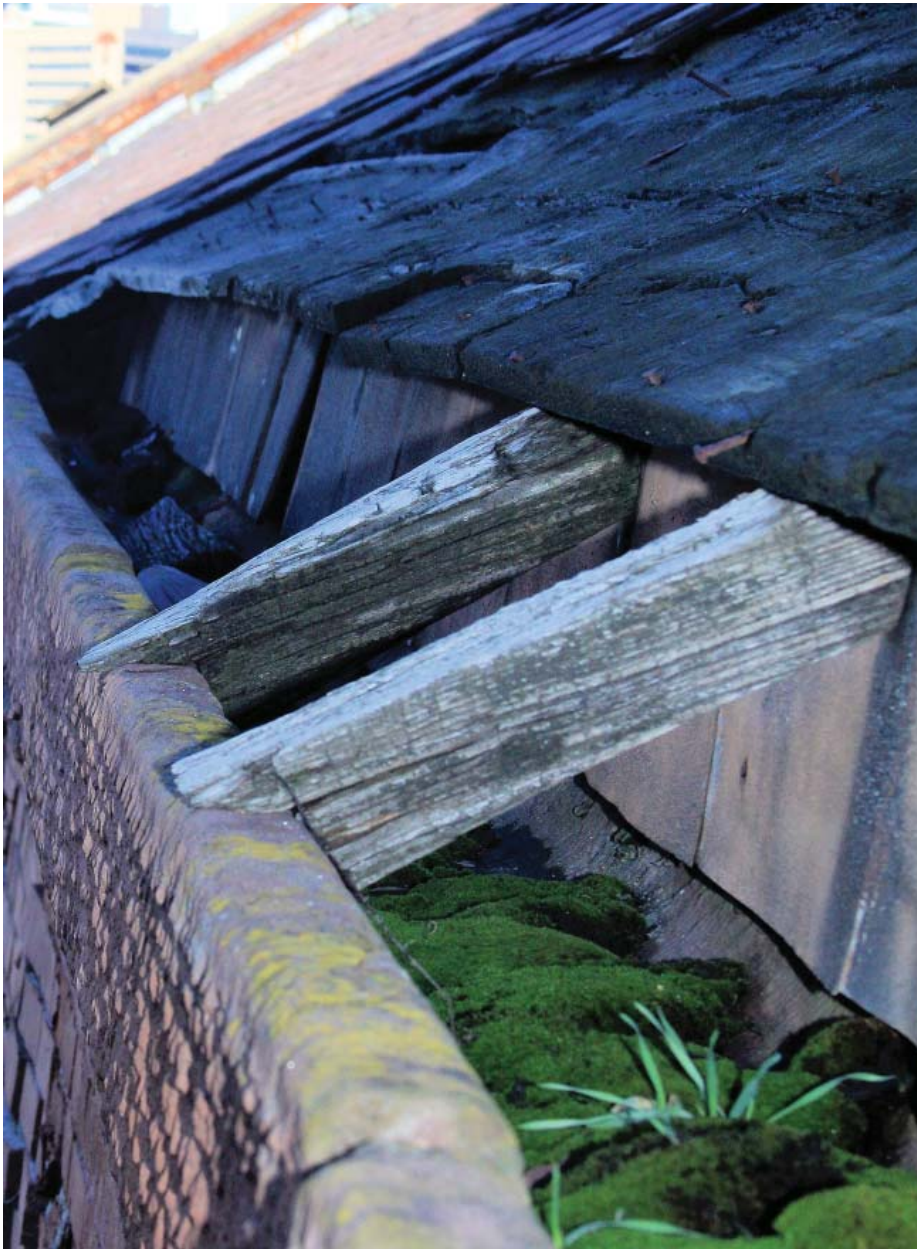
Roofing – It was not possible to read the roofing material from figure 2, but figure 3, a detail from an 1864 photograph looking towards part of the east face of Building 8, showed slate roofing. It appeared to extend over the cornice, shedding rainwater to grade. This is puzzling since site investigation by EYP has revealed that the top surface of each brownstone cornice unit was gently channeled to form a built-in gutter. At Building 10, this survey also found remnants of sheet metal flashing that ran up under the slate and directed water down into the stone gutter. See figure 11.

Figure 11. Kickers added over original stone gutter, Building 10, west elevation.

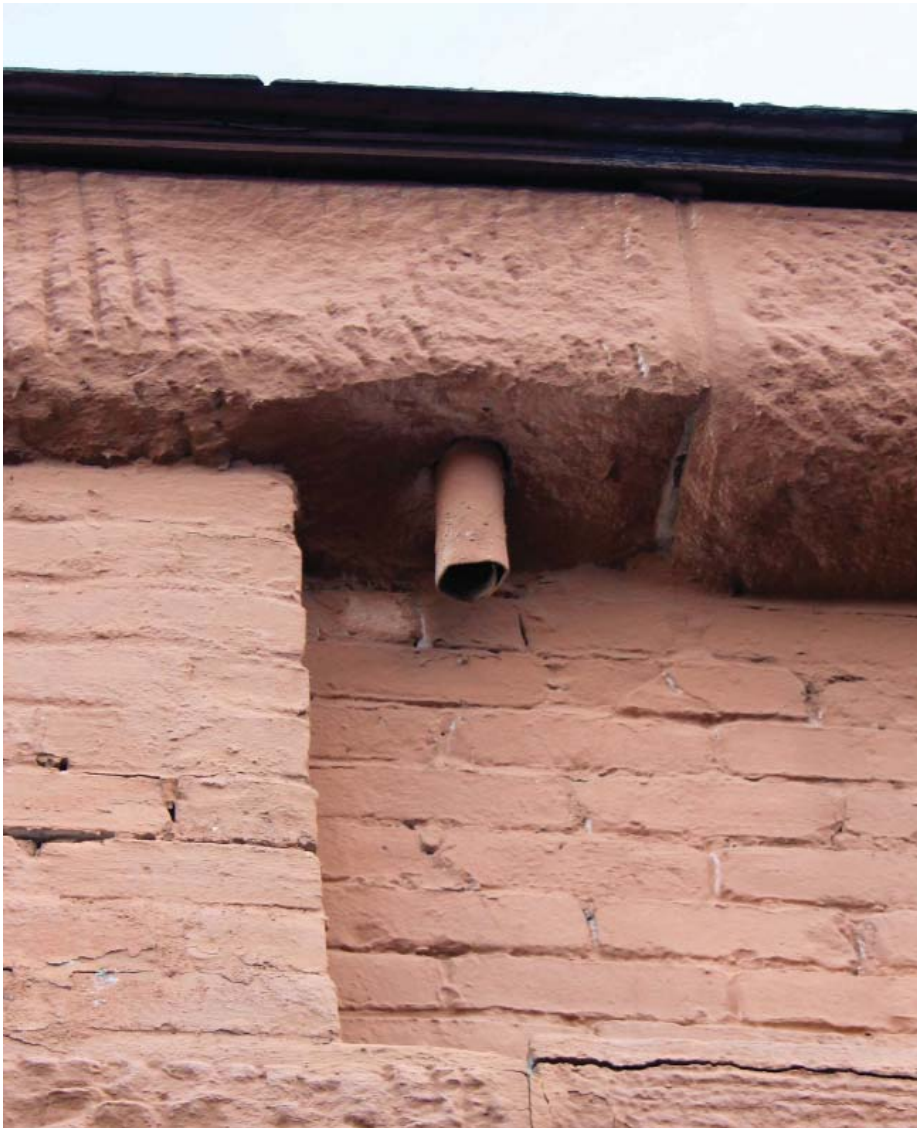
Figure 12a. Outlet from stone gutter, Building 10, west elevation.

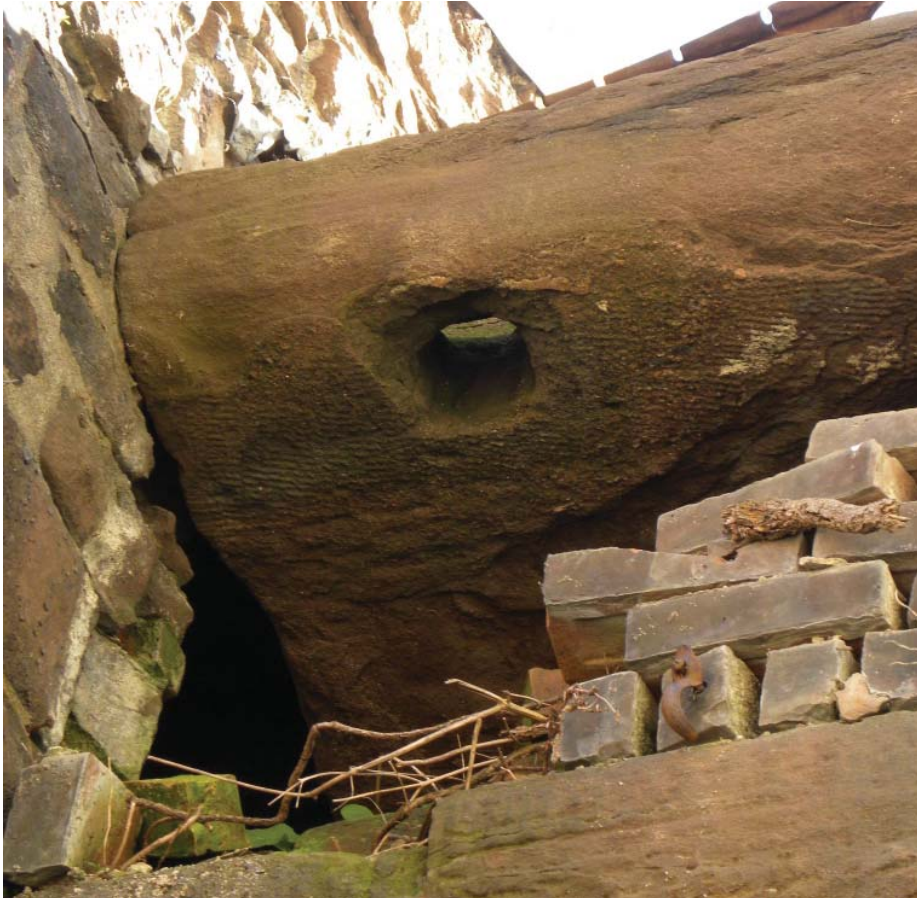
Figure 12b. Hole for outlet from stone gutter, Building 8, east bay 27.

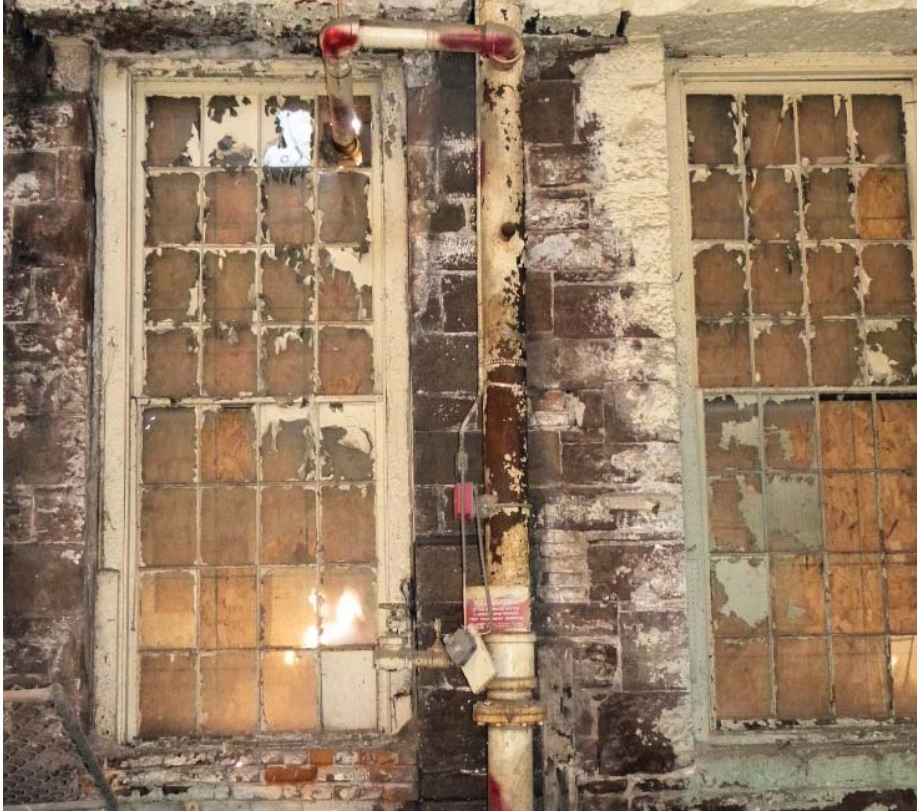
The interior structural masonry of all four walls was mostly roughly dressed brownstone – erected as piers along the east and west walls and as plane masonry at the gable ends. The piers were of rubble type construction with load-bearing brownstone finish units and a center fill of stone, brick and mortar. The interior window opening and doorway jambs, as well as the window sills, were smooth brownstone as they were at the exterior. The brownstone units forming the window heads were left with rock faces that often protruded several inches out from the general plane of the masonry. This detail was picked up in the etching in *The United States Magazine* article (Fig. 16). Beneath the windows of the long sides were the same spandrels seen on the exterior, brick alternating with brownstone. Both materials were set flush with the inner face of the piers.

Figure 18. Characteristic view of perimeter wall bay, Building 10, east wall. Note wood windows and casing and alternating brick and brownstone masonry panels below.

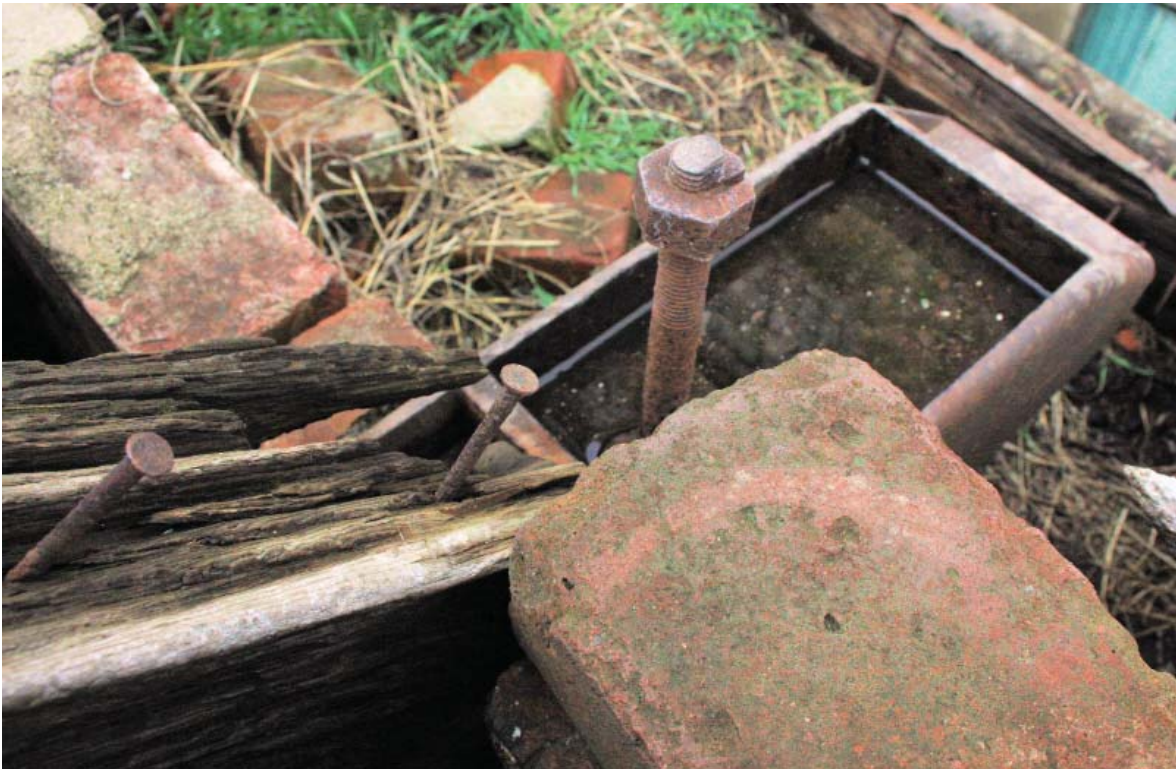
Ceilings and Roof Structure – The bottom chords of the unprotected composite heavy timber trusses that supported the roof created the original open ceiling line. They were provided with wrought iron rod and connecting hardware creating a queen post truss. See the HABS/HAER photograph from 1905, Appendix A, plate 9. Although there were some modern repairs visible at that date, there is no reason to believe these trusses were not original. Figure 16 drawn in 1857 illustrated the trusses with exactly the same configuration of heavy timbers. The trusses, one per bay, were connected by two purlins on each roof slope and supported wood rafters that in turn carried roofing boards. The ends of the bottom chord and the sloped chords of each truss were set into a cast-iron shoe set on the brownstone units that made up the cornice.

Figure 19. Cast iron shoe and anchor for truss bearing end, Building 8.

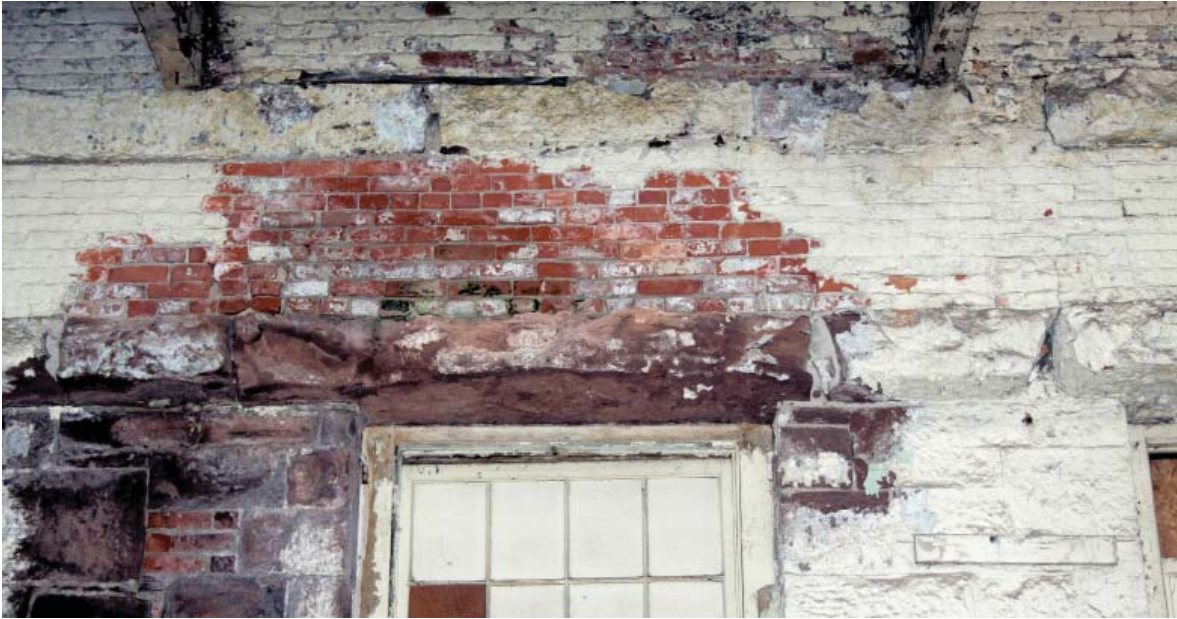
levels single units of brownstone spanned this entire depth and even cantilevered out slightly beyond the interior face, while the outer and inner brick walls were separated by about 20 inches creating a hollow masonry tube within the 'entablature.' Initial site investigation suggested strongly that in Building 8 this tube ran the entire length of the east and west walls and that there was similar construction within the eastern part of the south wall but not within the north wall. It cannot be known whether it originally ran the full width of the south wall because the west end of this wall was completely rebuilt in altered form in brick at some later date. If it did, it would have created a continuous horizontal U-shaped duct.

Figure 20. Interior view of entablature, Building 10, east elevation.

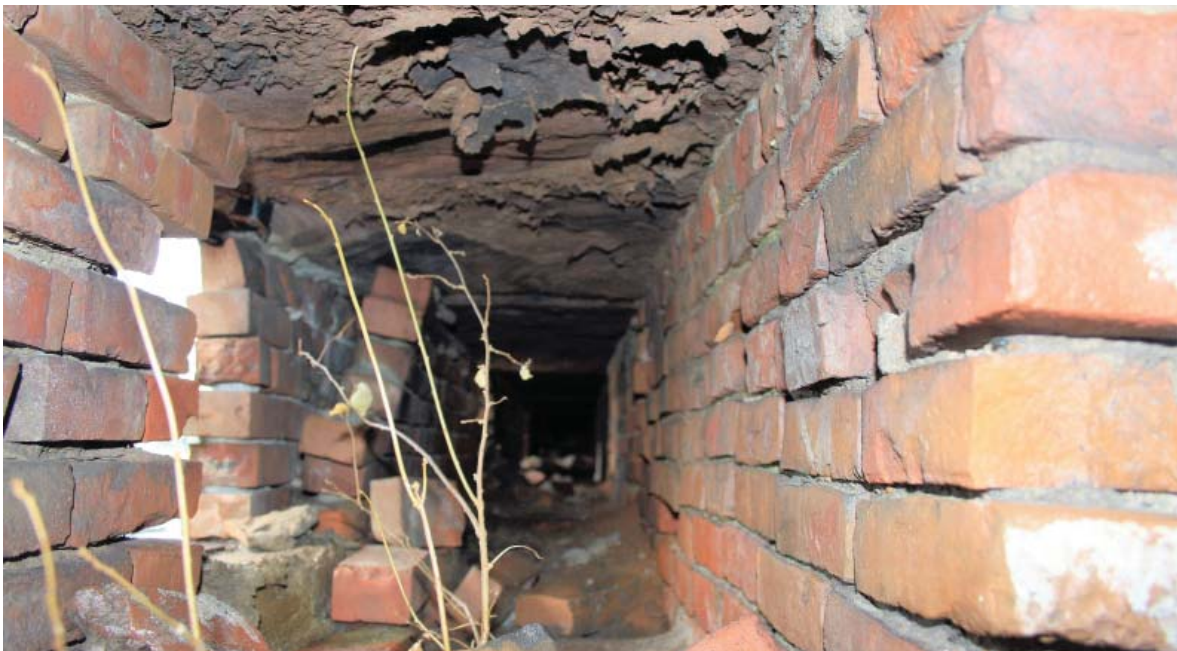
Figure 21. View along masonry duct, Building 10, west elevation.

Wherever access was feasible, the EYP site survey ascertained that the same horizontal duct ran through the entablature of all four walls of Building 10. One could also see rectangular holes cut at regular intervals in its brownstone floor. The intervals coincided with the centerlines of every other pier. It is in these piers that patches of brick infill were noted throughout the interior elevations of both buildings.

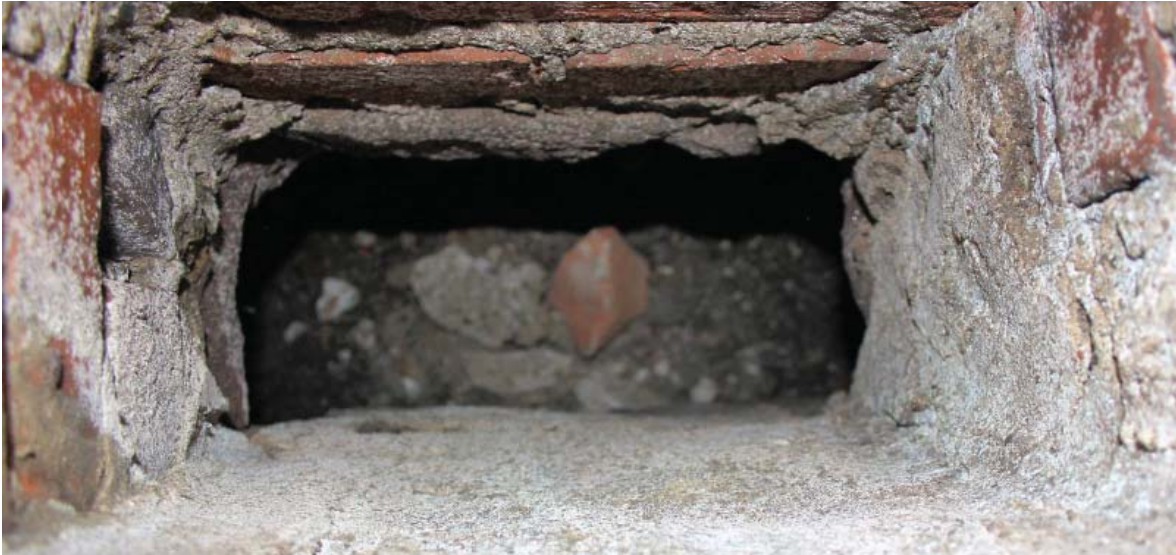
Where these patches were already partially open, or where loose bricks could easily be removed, it was possible to confirm that some piers were also hollow. From the distribution of patches, it appeared that every alternate pier were in this condition. In the piers investigated, a rectangular shaft about six inches by fourteen inches led up from the

uppermost line of patches typically about four feet below the window head to the floor of a horizontal duct. Here, as far as could be determined, a hole was cut in the brownstone unit at the top of every alternate pier. There is every reason to believe that this system of linked masonry stacks and ducts was the same in both buildings and was an original feature. Its function is examined immediately below.

Figure 23. View down vertical stack in pier, Building 10.

Ample soot was found in several of the vertical stacks that were explored during the site investigation. From the built evidence of these flues, and from *The United States Magazine* illustration, one can conclude that the forge was built with hearths at every other window bay on both sides of the building. It seems highly unlikely that such a major investment in masonry and machinery represented a change made between 1855 when the factory opened, and 1857 when this illustration was drawn. And the hidden exhaust would have accounted for the wonder expressed in the accompanying article about the smoke-free environment of the forge.⁷⁵

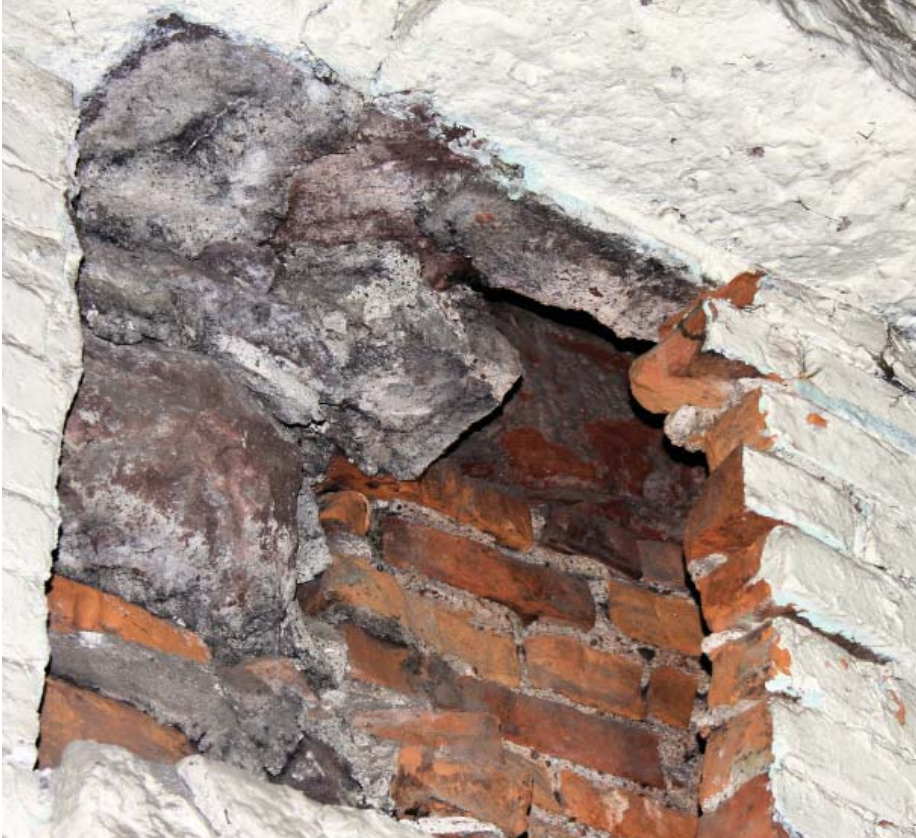
Figure 24. Opening from vertical stack to horizontal masonry duct, Building 8.

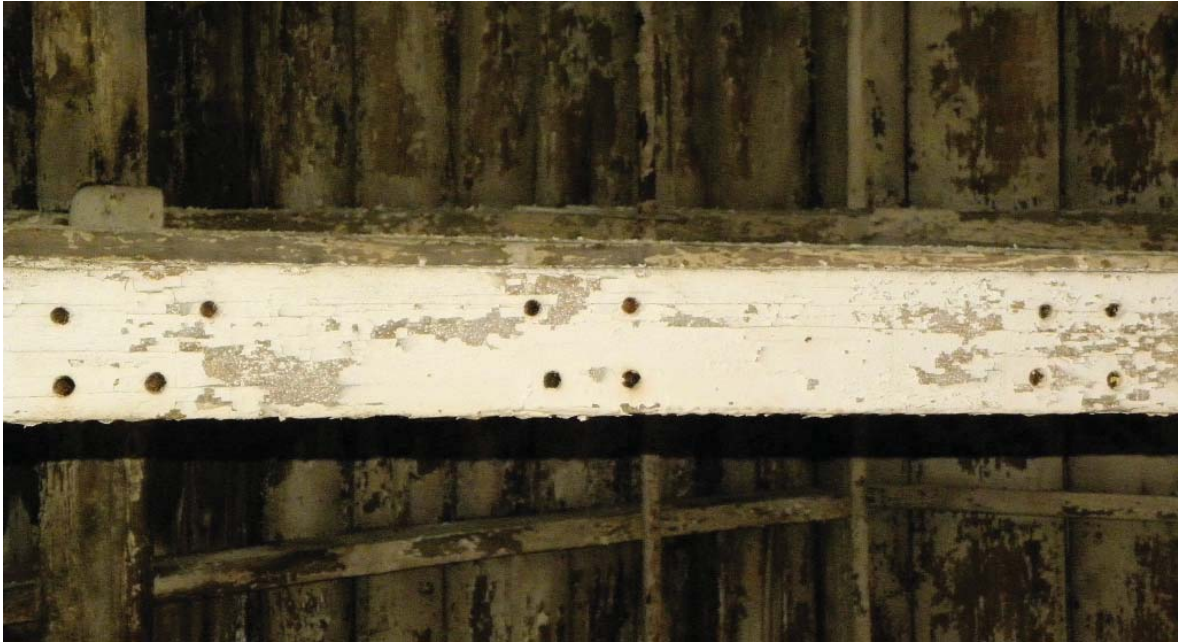
Figure 16 showed a double row of drop hammers marching down the central zone of the forge shop, tied back overhead to the bottom chords of the roof trusses. It should be possible to discern the pattern of their attachment from close inspection and analysis of holes in the bottom chords of the trusses, some of which can be seen in figure 25.

Figure 25. Representative pattern of holes in bottom chord of a truss, Building 8.
