Buildings 8 & 10

Historic Structure Report

Coltsville National Historical Park
Hartford, Connecticut

2017

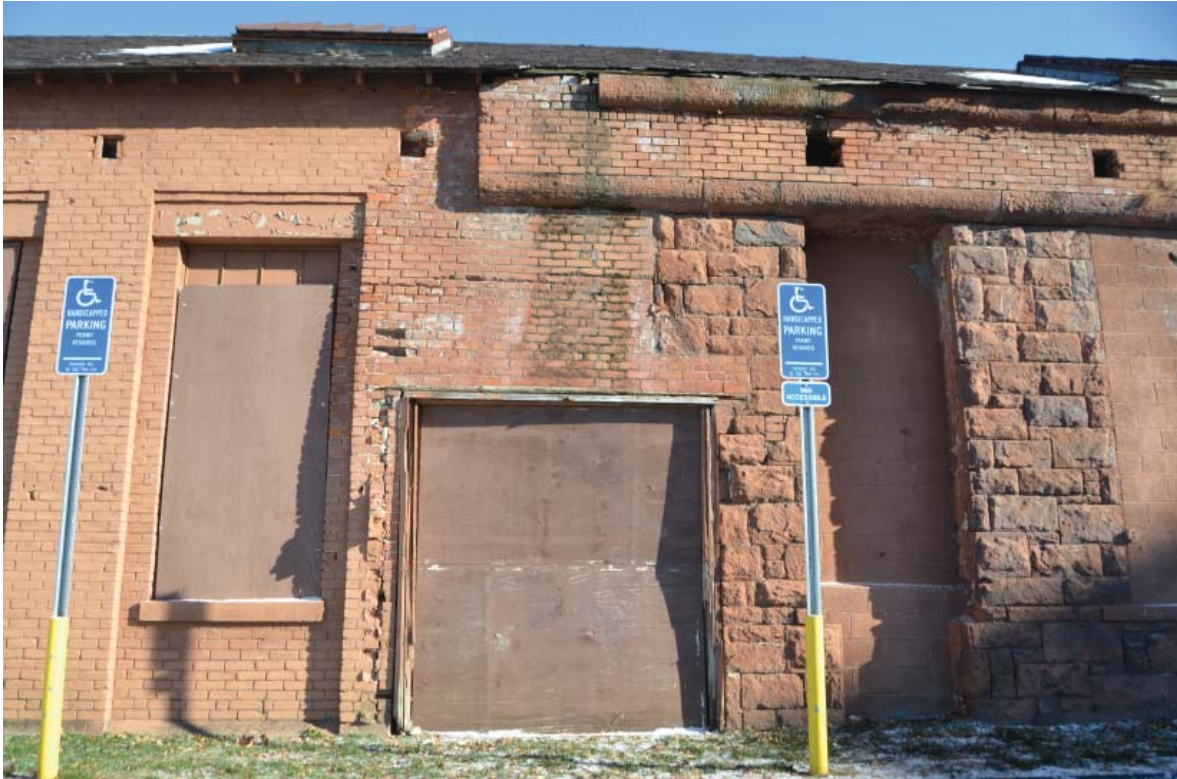
found to date can only suggest that this occurred between 1938 and 1965. The block infill at bay 12 may have been placed at a different date, since it is set back from the plane of the wall, unlike all the other fill in the window openings to the south. See figure 42c.

Figure 42c. Bays 11 and 12, Building 10, west elevation.

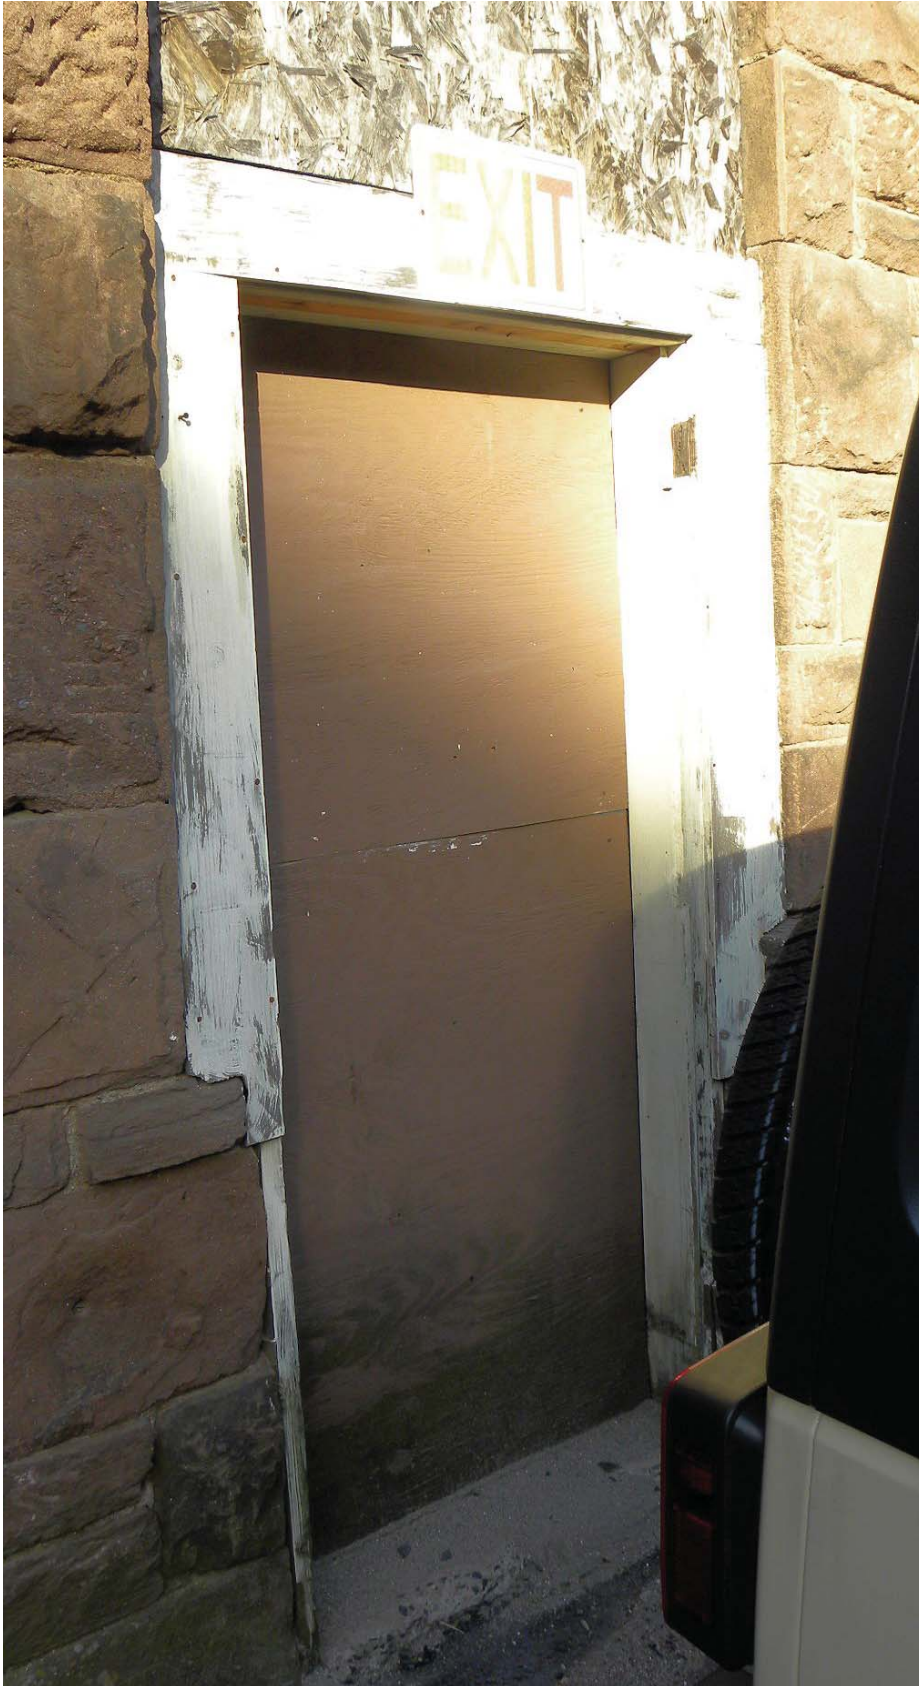
Figure 45b. Doorway cut into window bay 12, Building 10, east elevation.

In this east elevation of Building 10 there were two original doorway openings as discussed above. One at bay 9 retains its original form (Fig. 7). The second at bay 19 has been widened (Fig. 45a). A third doorway has been created out of an original window bay at bay 12 (Fig. 45b). From signs still mounted on the exterior face of the wall above the latter two, it appears that they were created and used as exits from the hardening and heat treating building into Building 10. This work must have been done between the late 1960s and about 2005, outside the period of significance.

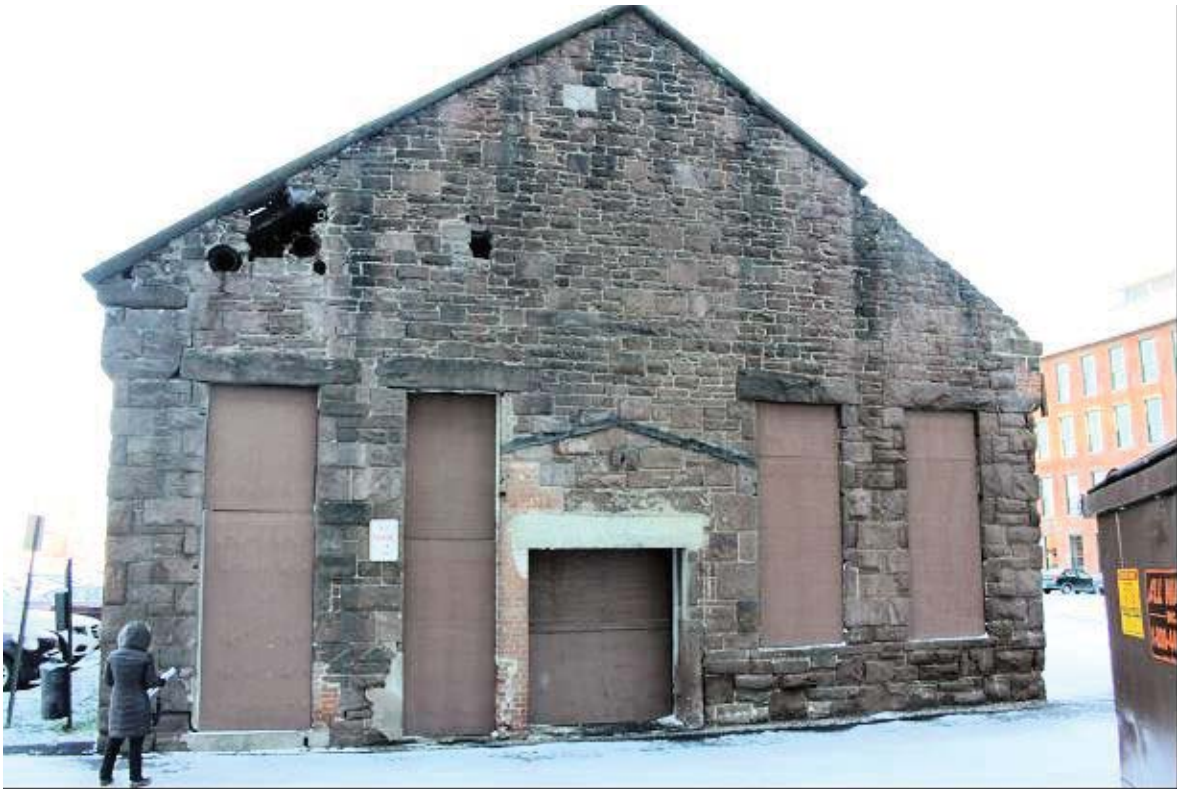
Figure 46. South facade of Building 10.

The evolution of the south end of Building 10 is harder to read, although the basic design of 1855 is still visible. The aerial photograph of 1970 seemed to suggest that some sort of link structure had been built, connecting Building 10 to the South Armory. It may have been present before, but the earlier aerial photographs were not clear, and no link was drawn in the 1938 survey (Fig. 36, extreme right-hand side). It seems to have survived until at least 1995, when it can just be made out on the aerial photo (Appendix C, plate 7). This link would explain the gable-shaped trace of mastic, a shallow inverted V, over the location of the original centered door. It appears to have been demolished by 2004 since no outline of a structure appears in that location in the geotechnical report provided to the NPS at that time.⁹²

One might also surmise that once this link was installed, the new doorway seen in figure 46 was built in the original extreme west window opening. It would have recreated direct access between the yard and Building 10. But it could also have been created to provide a second means of egress from the cinder-block electrical closet that has been erected in the southwest corner of the building. An exit sign hangs on plywood blocking above the metal door which is hidden behind the plywood paneling visible on the exterior. No date for these doorway alterations, nor for the

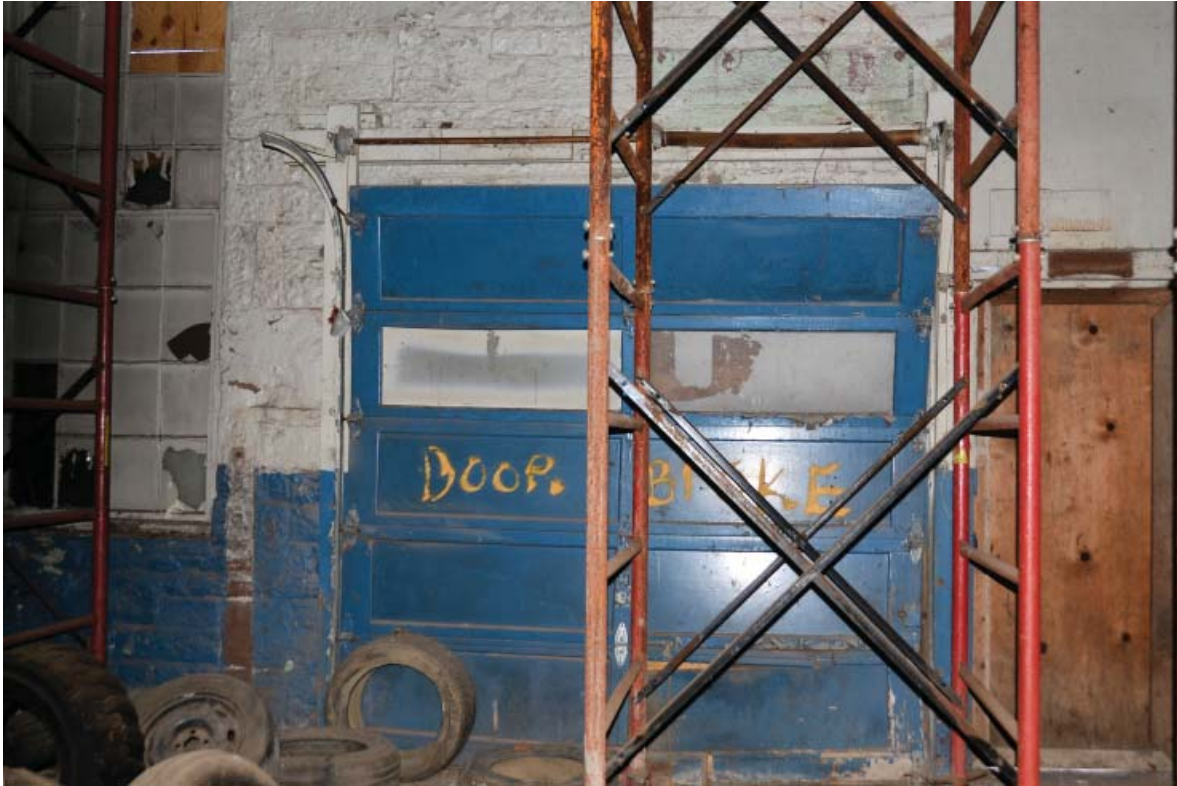
Figure 47. The south wall of Building 10, interior view.

The original center doorway has been altered, perhaps to provide fork lift access through the link during the later years when the building was used for storage, or perhaps to the parking lot after the demolition of the link. It has been furnished with a drop-down paneled door (Fig. 47) and has certainly been widened but not symmetrically. While the original east jamb remains, the west jamb has been demolished. A new west door jamb built of brick has been built within the original window opening immediately to the west (Fig. 48). This jamb, together with the altered remainder of the window opening, was actually used to form another small doorway. It lacks a door; the opening is protected only with plywood. Behind the plywood panels in the window openings to the east, the sashes remain in place.

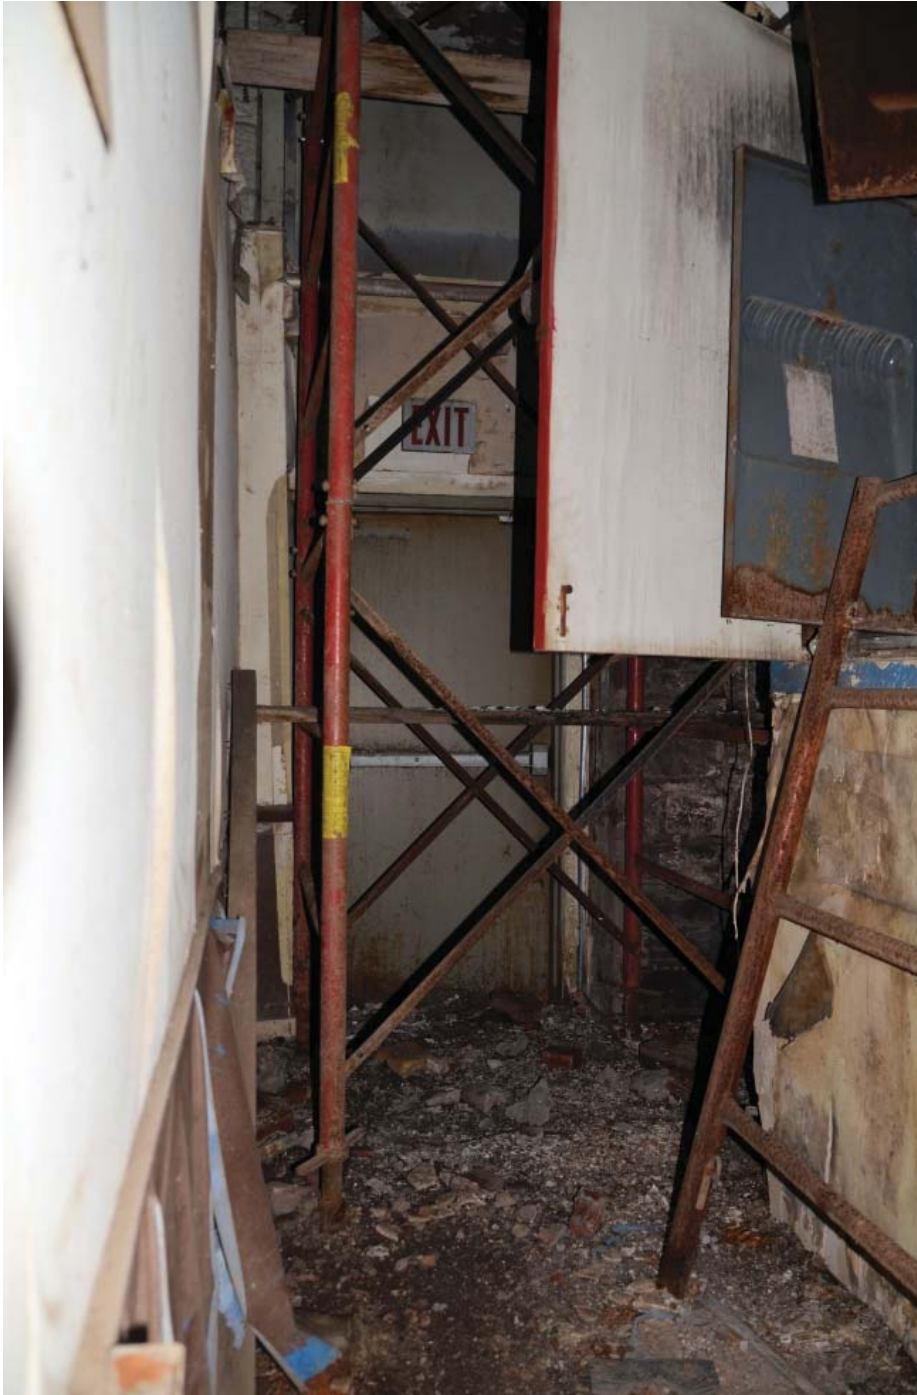
Figure 48. Exit door from the electrical closet, Building 10, southwest corner.

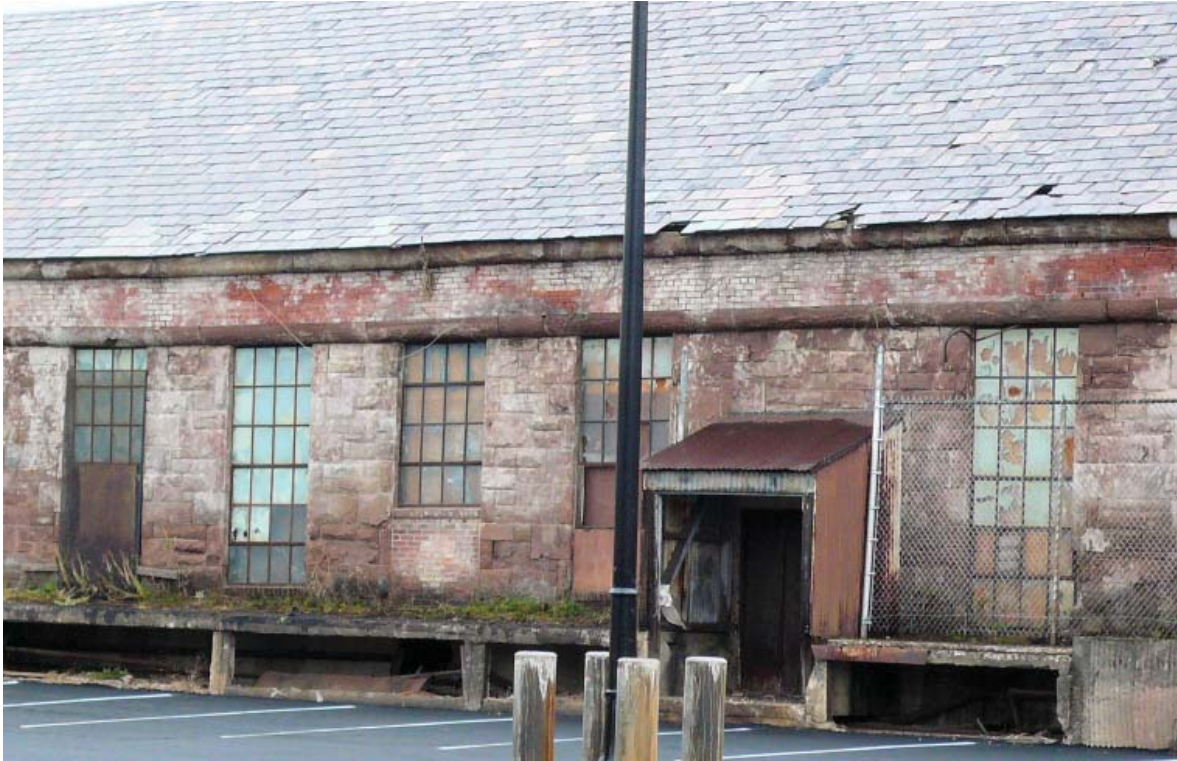
Figure 49a. Opening to the west, and pipe tunnel, Building 8, west elevation.

As discussed earlier in relation to the question whether there were any original doorways in the west elevation, the 1938 survey did show an entry at bay 9 of the west elevation of Building 8. It was clearly the doorway that still remains at bay 9 where the pipe tunnel, which otherwise runs partly above grade, is offset below it (Fig. 49a). The doorway was probably created to provide access from the woodworking building (Building 8) to the lumber store. The 1951 aerial survey photograph showed the store had already been demolished; this suggests that Building 8 might no longer have been a woodworking shop by then.

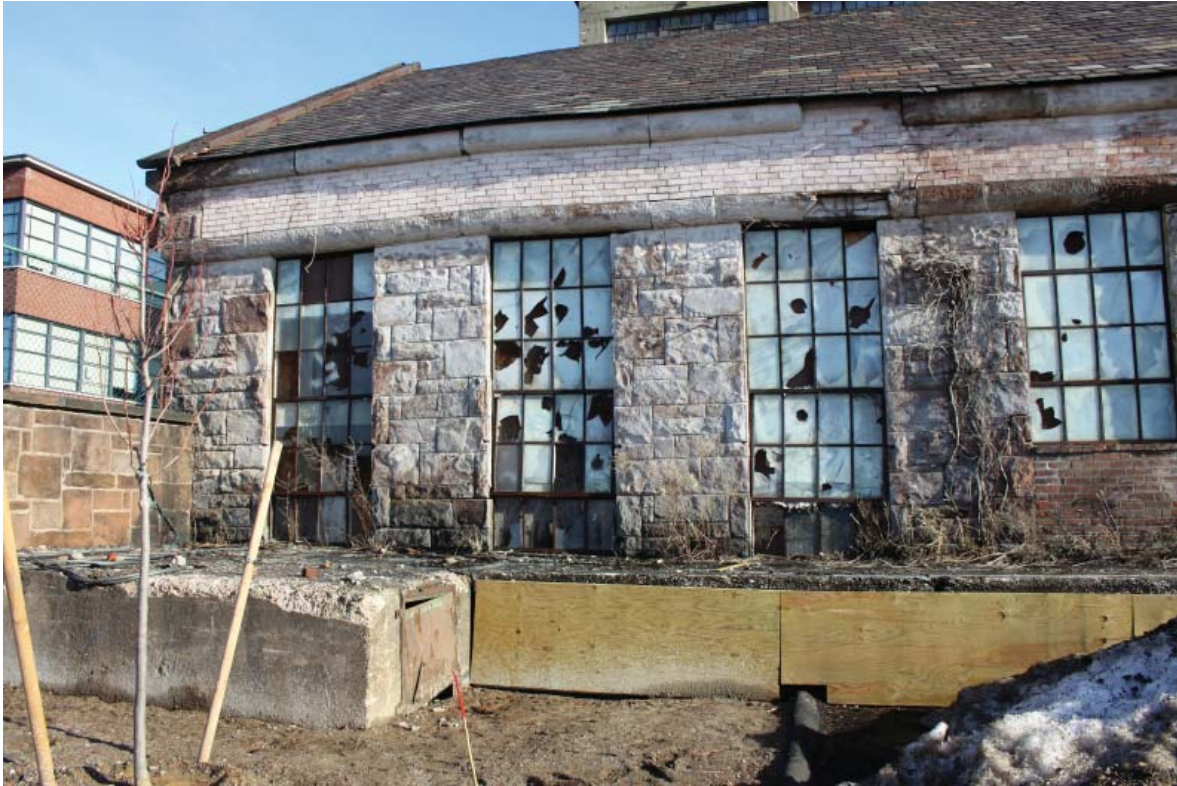
Figure 49b. North end of the pipe tunnel, Building 8, west elevation.

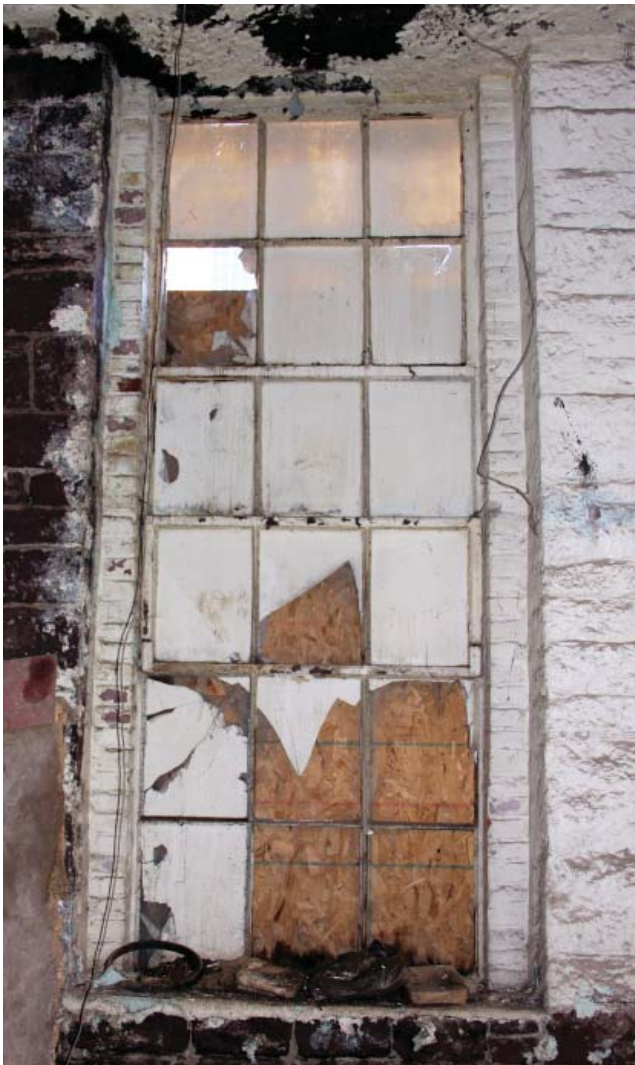
Figure 50a. Metal sash between original brick jambs, Building 10.

A typical detail of the metal window installations makes it quite clear that they replaced a wood window system. As they have pivoting operating sashes that require no counterweights, the metal windows were chosen to fit between existing brownstone jambs with the frames placed to cover the transition between brownstone and a brick offset, as can be seen in figure 50a. The earlier wood windows with double-hung sash extended over these offsets, which accommodated the extra width of their counterweight pockets. The pockets were covered with wood casing, as can be seen in figure 50b. No casing was provided around the metal windows. As a result, the brick jambs became visible, as they remain today.

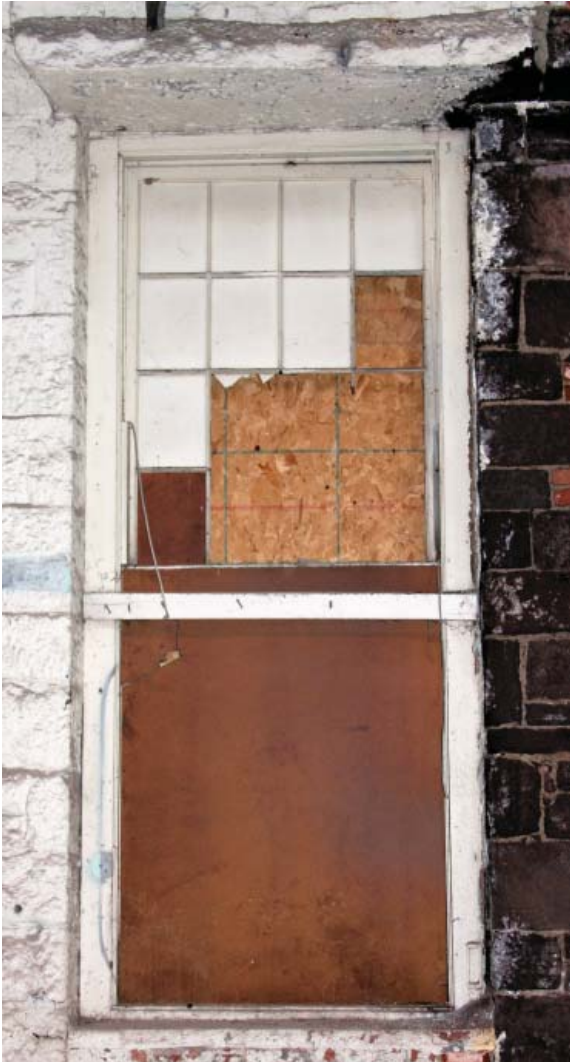
Figure 50b. Wood sash with casing over brick jambs, Building 10.

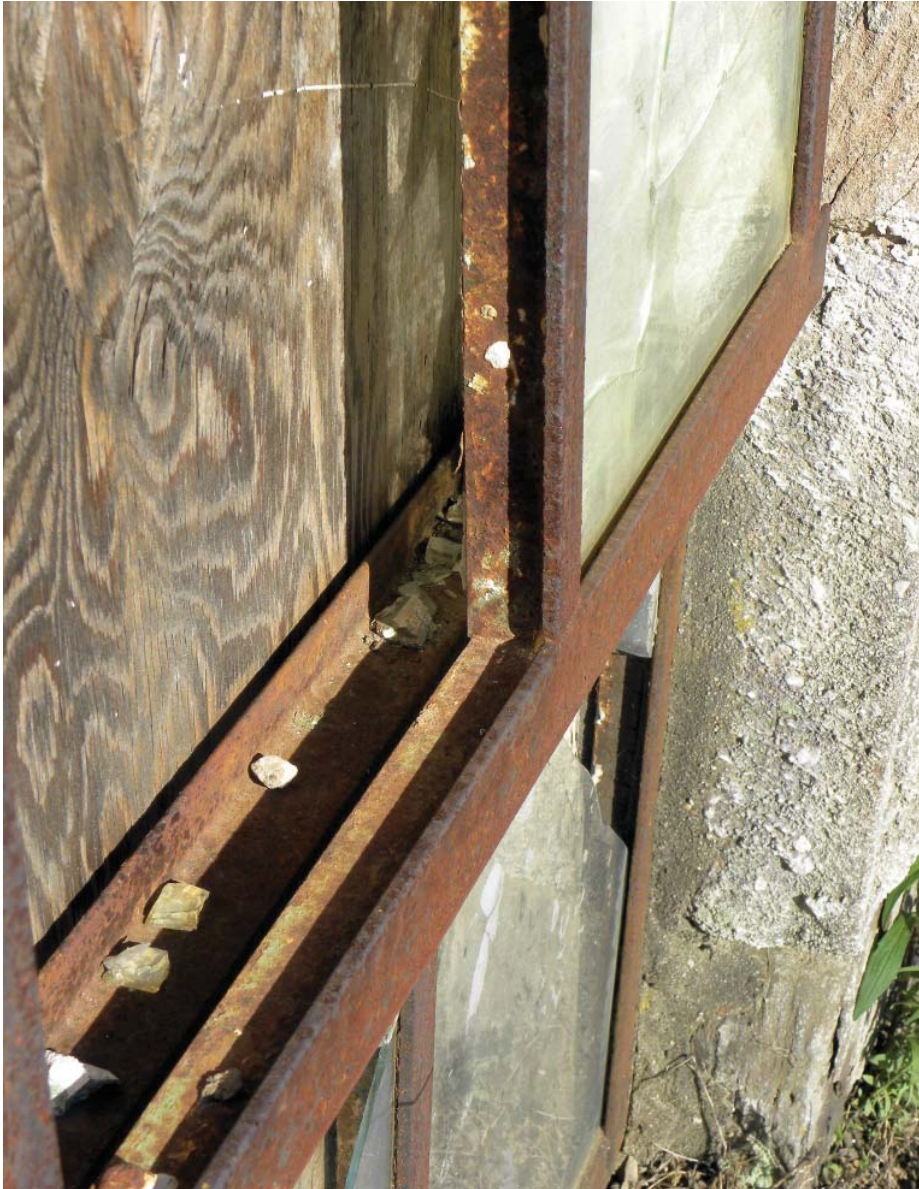
Figure 51a. Bar stock frame with ridged glass, Building 8.

Although the metal windows at Building 8 typically had the same pattern of divided lights, fixed sashes and a central, operable pivoting section, the frame, muntins and mullions differed. Two styles of metal window were installed. In one, the extrusions had some depth and slight offsets and curves (Fig. 47c); in the other, these elements were just flat bars (Fig. 47d). This latter style was originally provided with translucent ridged-glass glazing units. Profiled metal sashes were glazed with wire glass.

Today, clear glass is randomly distributed among the divided lights of these metal windows. It has replaced broken units of their original glazing in response to vandalism and other damage that has occurred since the Colt Fire Arms Company completed its move out of the complex in 1993.

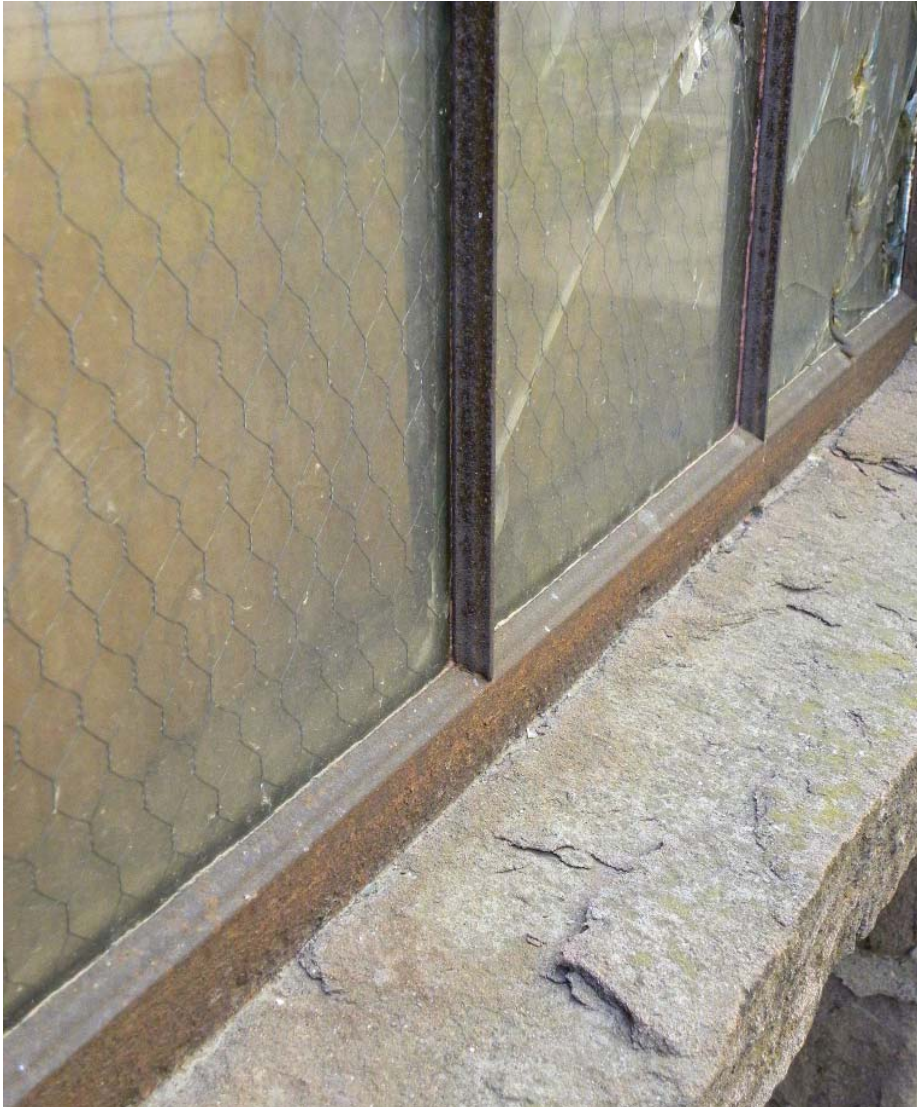
Figure 51b. Profiled metal frame with wired glass, Building 8.

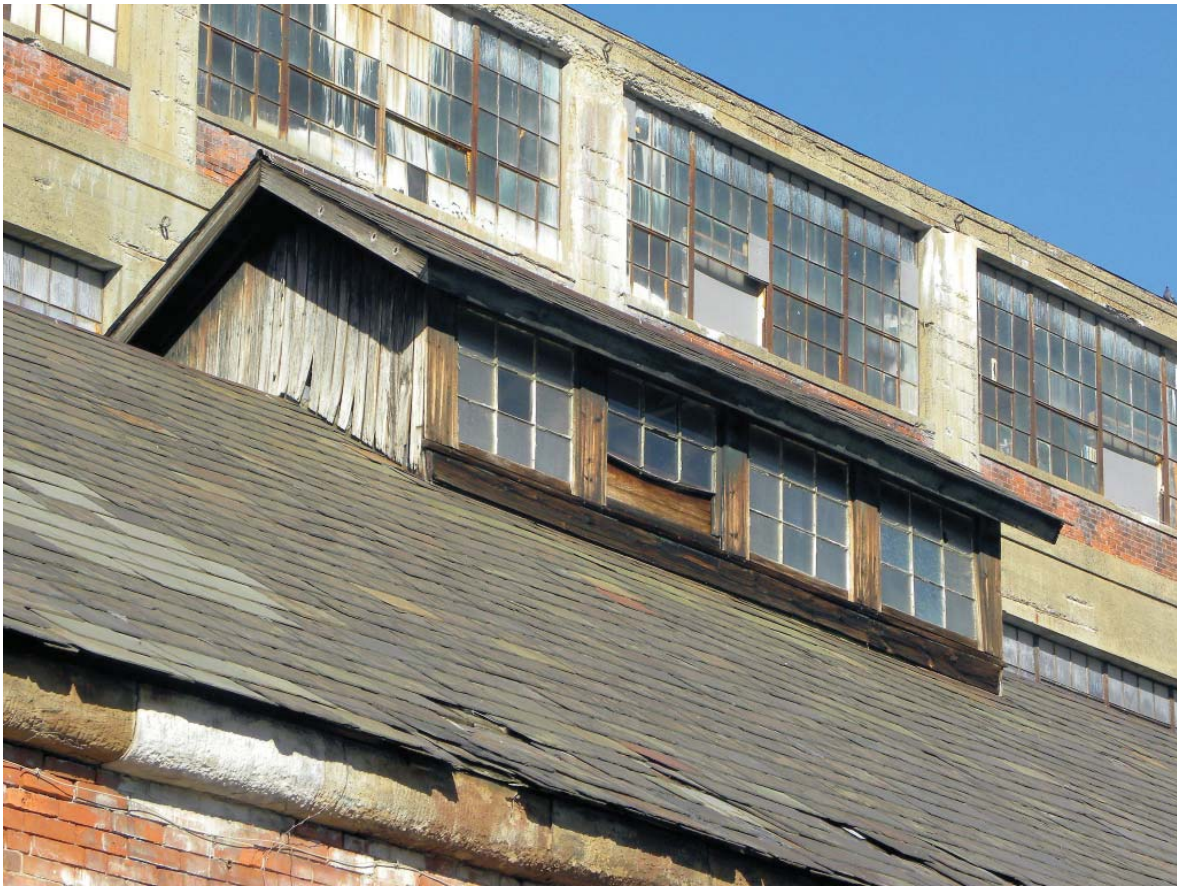
Figure 52a. Central monitor on Building 8.

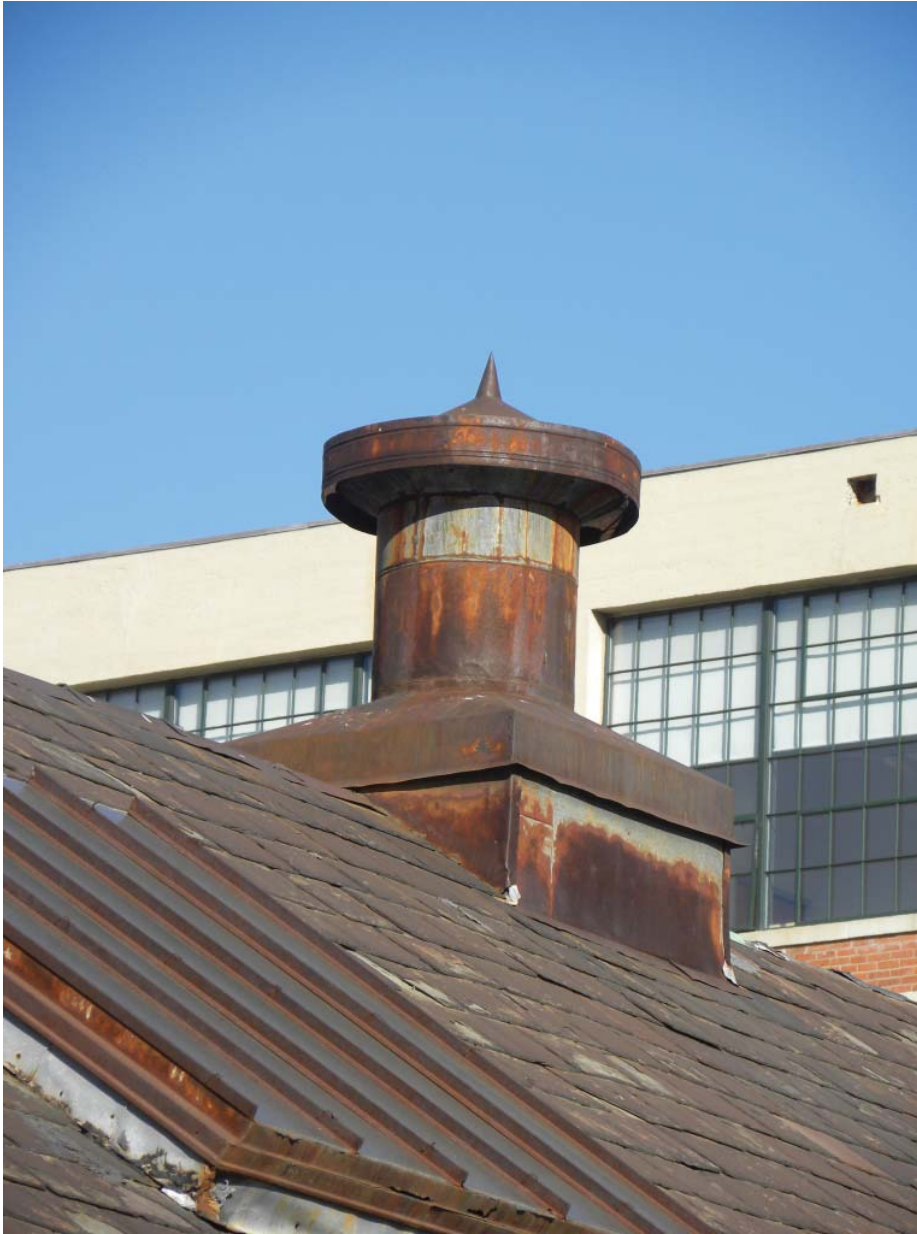
Figure 52b. Ventilator and skylight at Building 10.

The skylights were provided with lead or lead-coated copper flashing and simple lapped counterflashing (Fig. 52b). Much of the glazing was translucent ridged glass, but there has been some replacement in wire glass. If the skylights had been installed by 1919, the glazing hints that the metal windows along the west elevation of Building 8 may have been installed around the same date.

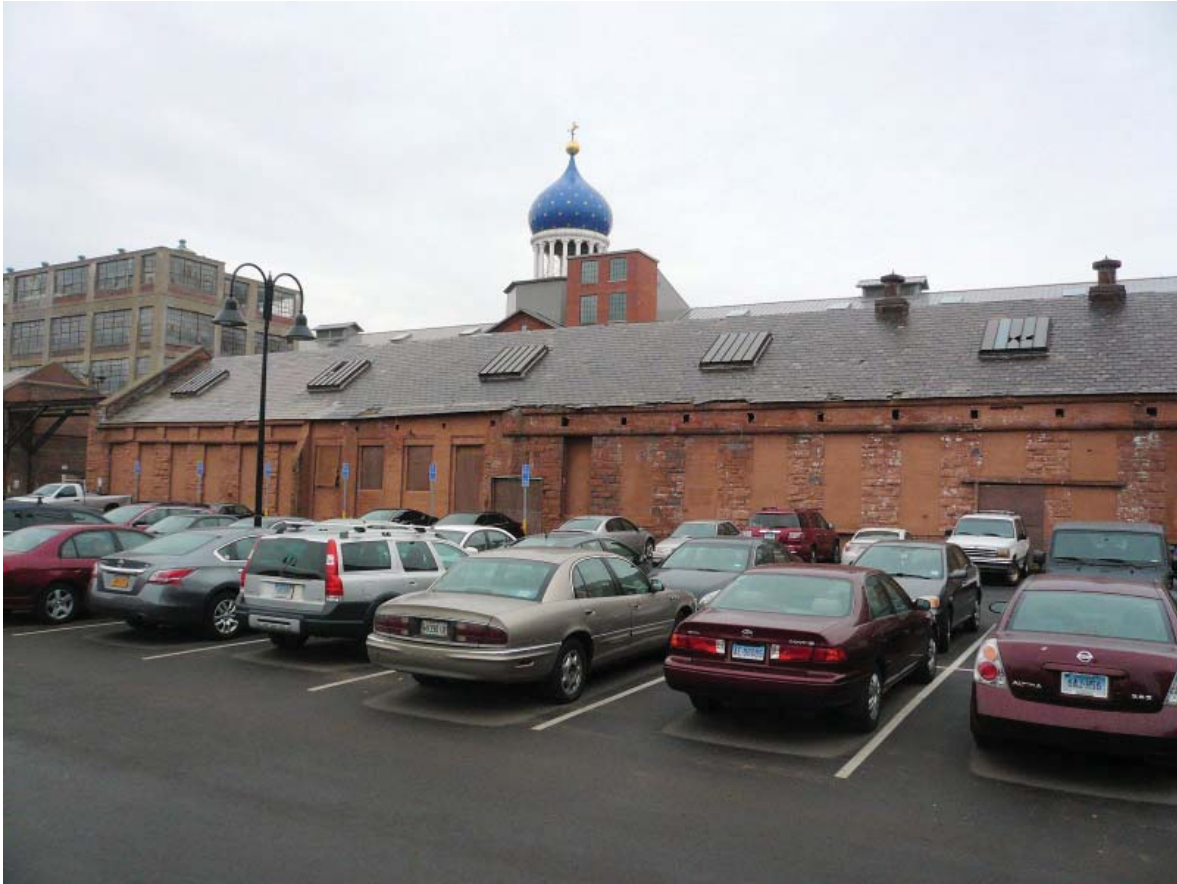
Figure 52c. Skylights and ventilators on Building 10.

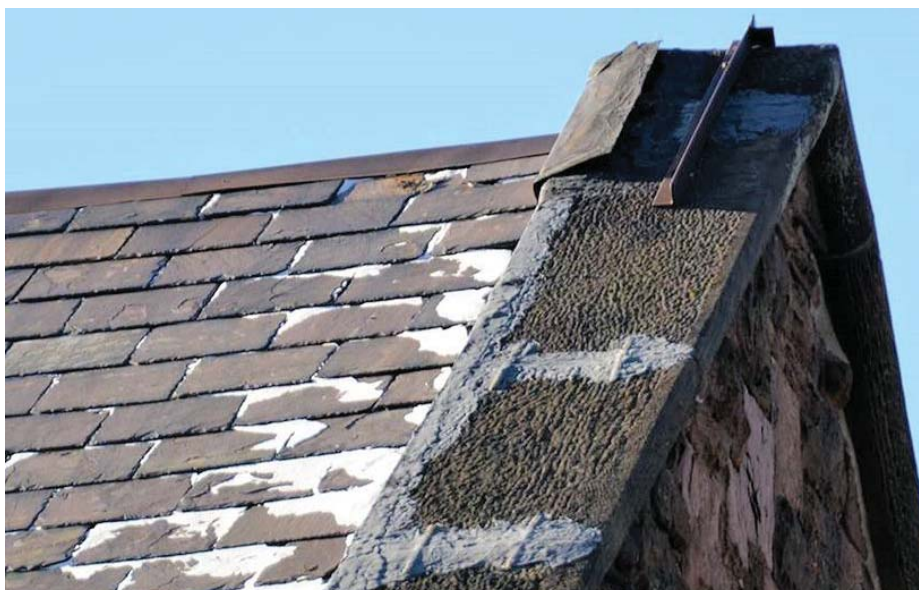
Figure 53. Metal flashing at ridge, Building 8, north end.

A current photograph (Fig. 5) shows a well-aged remnant of metal ridge flashing just behind the north gable end similar to that which was suggested in the 1861 photo of the south end of the same building (Fig.3). The site survey found discontinuous sections of similar metal flashing at the ridge of Building 10. It is likely that metal ridge flashing was an original detail but that most, if not all, of what is in place today was replaced at least 50 years ago.

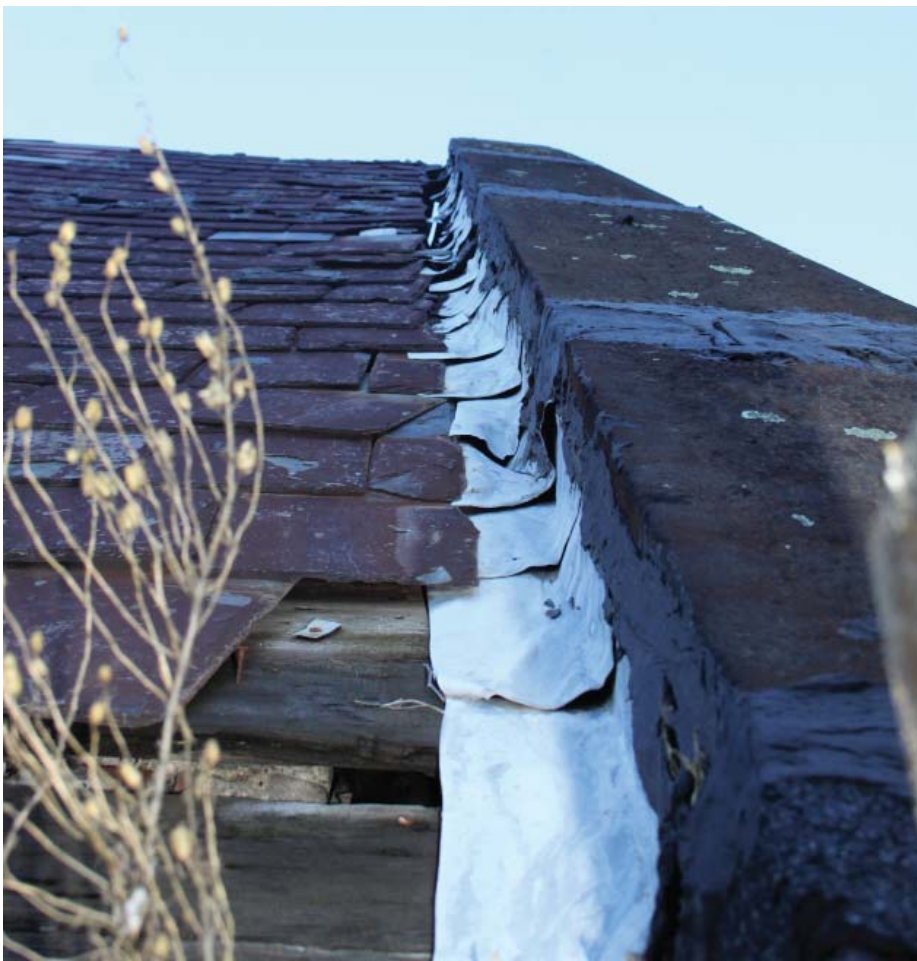
There are currently different styles of roof-wall counterflashing at the gable end walls of Buildings 8 and 10. Stepped counterflashing was installed on the raised gabled end walls outside the period of significance after the demolition of the spine. At the original gable ends, at the north and south ends of Buildings 8 and 10 respectively, the counterflashing is simply lapped in the same manner the skylights (Fig. 54). This suggests that the lapped counterflashing dates from around the same period, the end of the World War I.

Figure 54. Lapped flashing at the south gable end of Building 10.

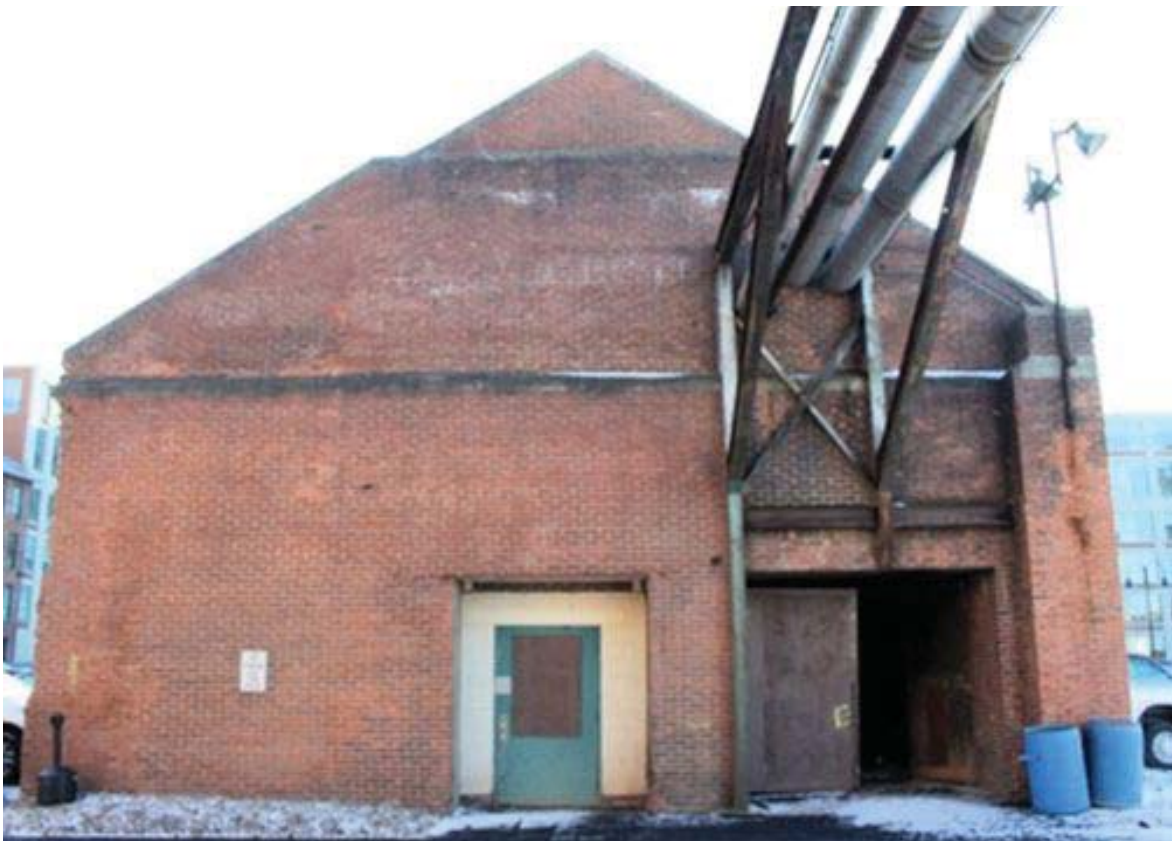
Figure 56. North elevation of Building 10.

The larger doorway opening at the center of the north façade of Building 10 (Fig. 56) was probably made at the time the brick veneer was added. It has since been partially filled with concrete block to recreate a smaller opening, probably when a second still larger opening was created at the west end of the façade (Fig. 56). The window openings to the east of the central doorway remain hidden behind the new brick ashlar. The window frames and sashes have been removed. There are no dates established for these alterations, but they must all postdate the end of the period of significance.

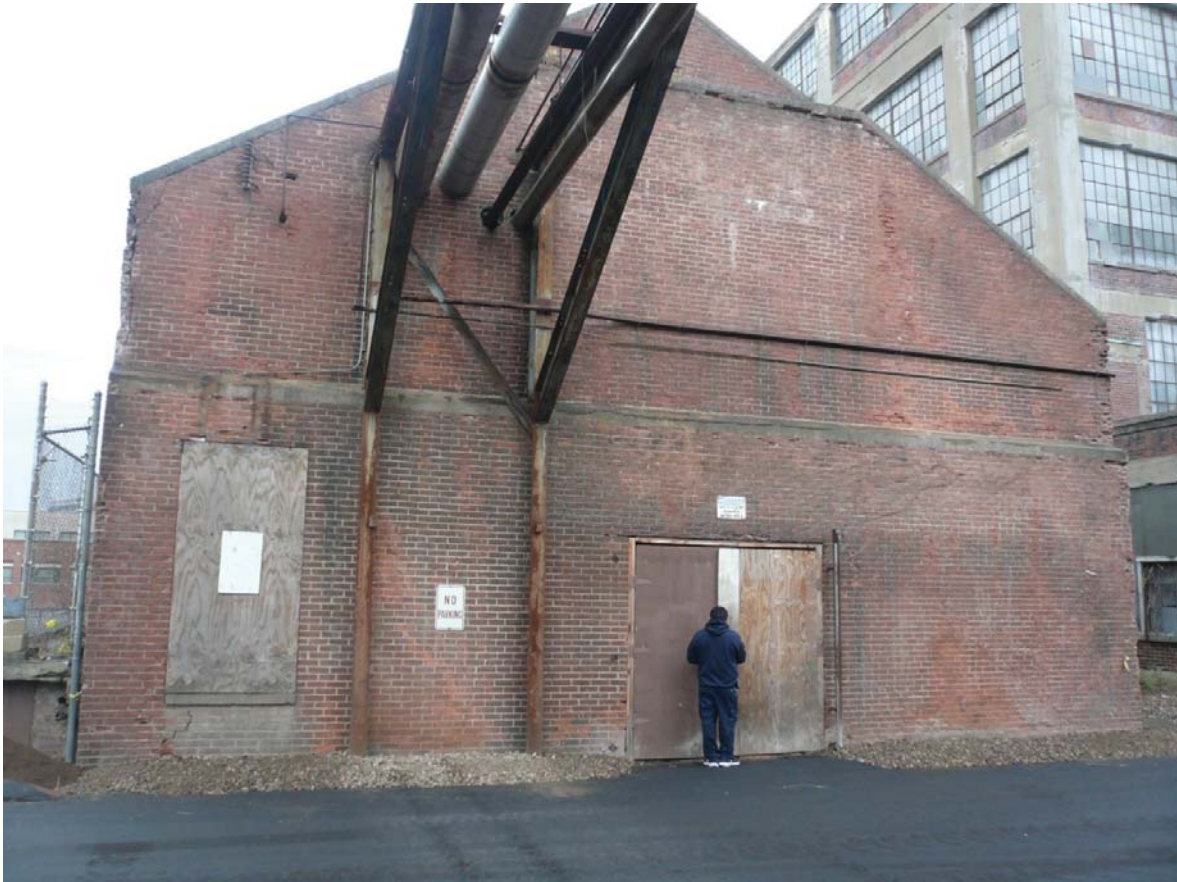
Figure 57. South elevation of Building 8.

Similarly, the large doorway near the center of the south façade of Building 8 (Fig. 57) was most likely created when the spine was demolished and truck access from within the site became possible for the first time. Like the new doorway in the south façade of Building 10, the metal-framed opening was located off center so that the new opening intruded into the original window bay immediately to the east but not into the window bay immediately to the west. Consequently, the window bay to the immediate east was completely bricked in so that the interior face became flush with the plane of the brownstone not only to provide support for the existing masonry above but to engage the recessed metal door frame. By contrast, two of the original window openings not impacted by the new doorway (i.e., the one immediately to the west and the other at the extreme east) were simply sealed by the new brick skin whose date of installation and details matched those of the north façade of Building 10.

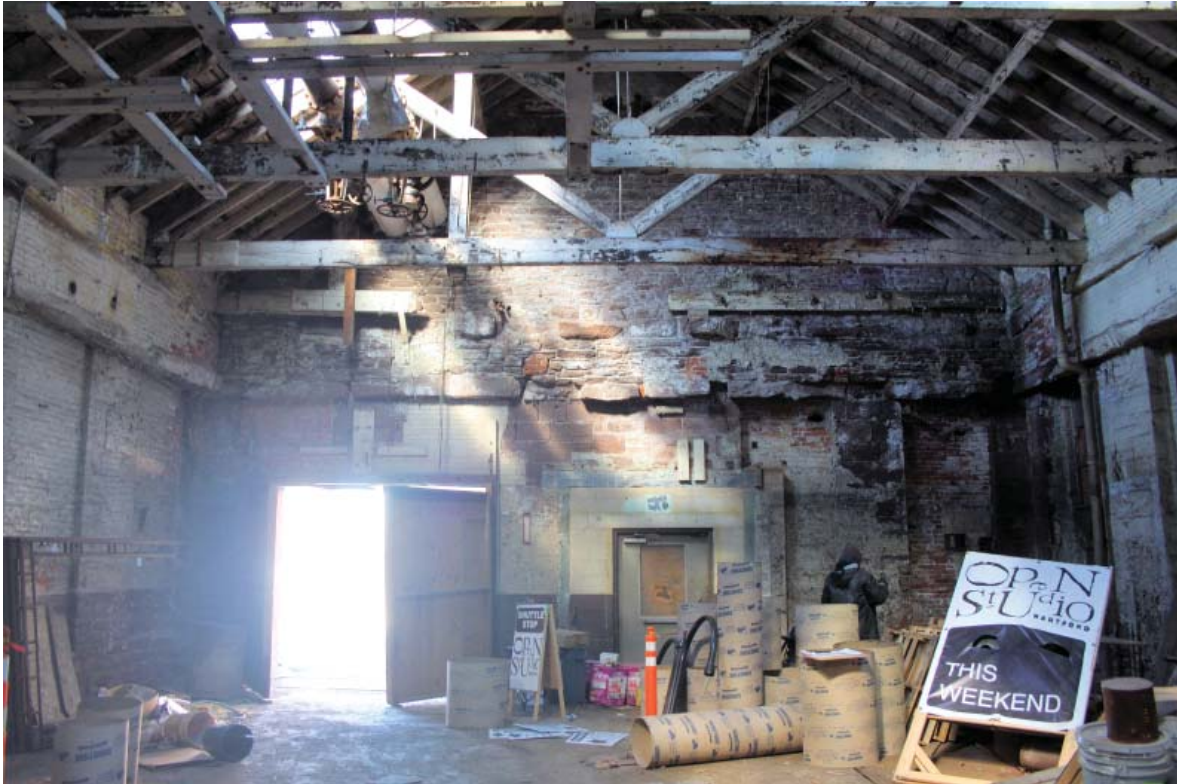
Figure 59. Building 10 as a storage facility, looking north. *Note change of character due to blocked-up window openings, altered doorways, and the steam pipes overhead that served the South Armory. Brownstone units in the north wall define the course of the horizontal masonry duct in that elevation. Bricked-in window openings can be seen at the east end of the same wall.*

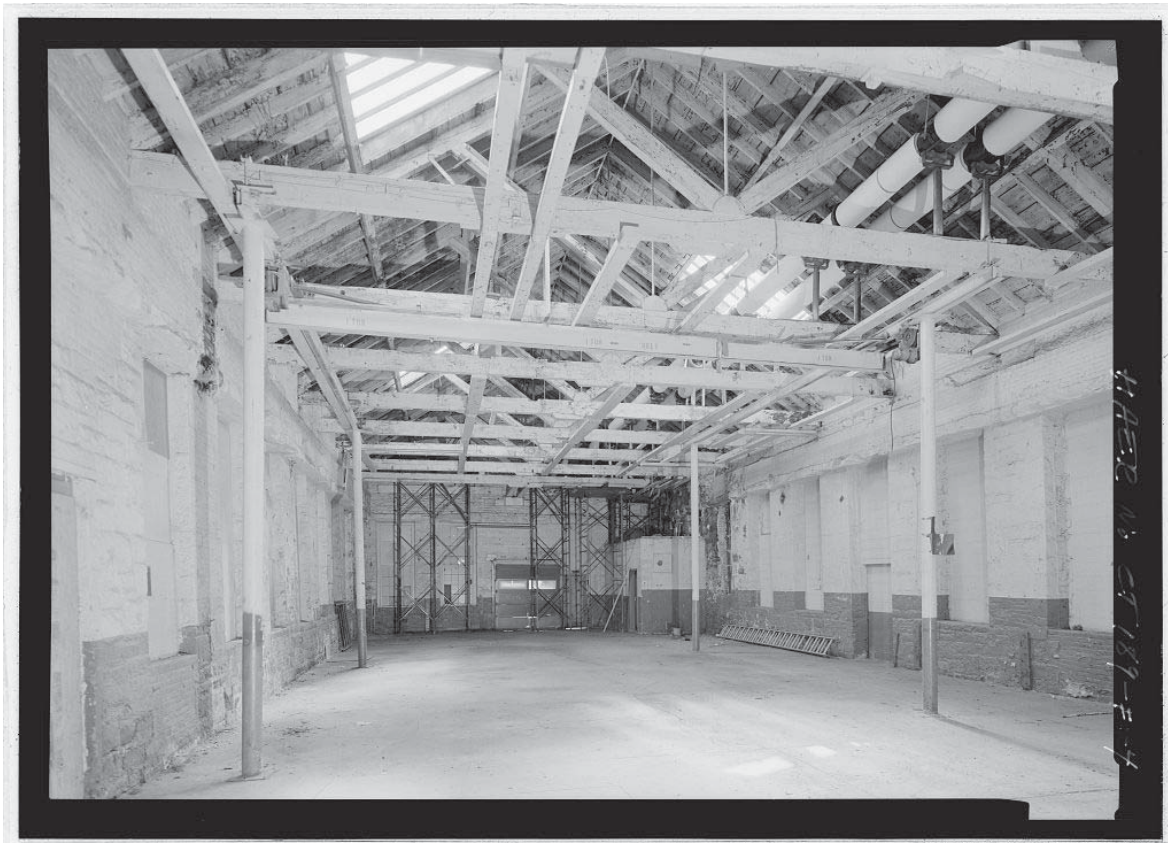
Figure 60. Building 10 interior looking south, 2005. *The modern electrical closet can be seen at the far end to right of center. Note pattern of window bays, alternating skylights.*
