Buildings 8 & 10

Historic Structure Report

Coltsville National Historical Park
Hartford, Connecticut

2017

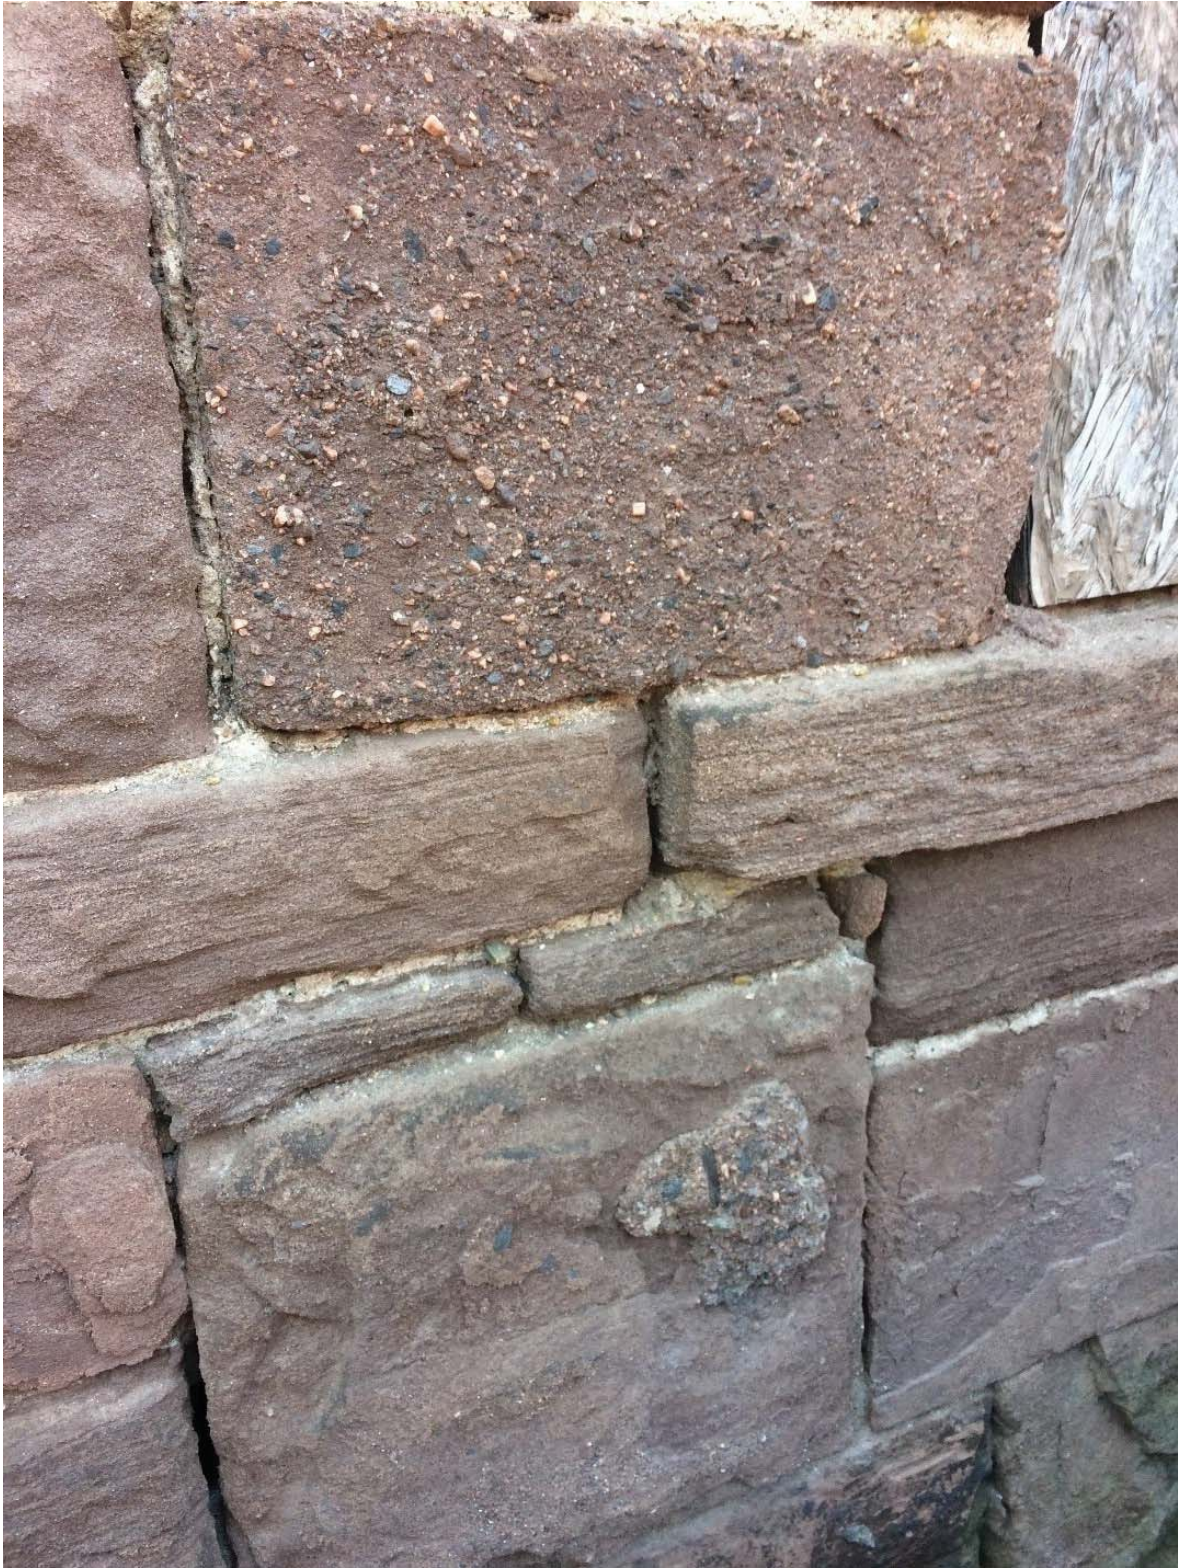
Figure 62b. Building 8, east elevation, rough aggregate concrete patches on brownstone.

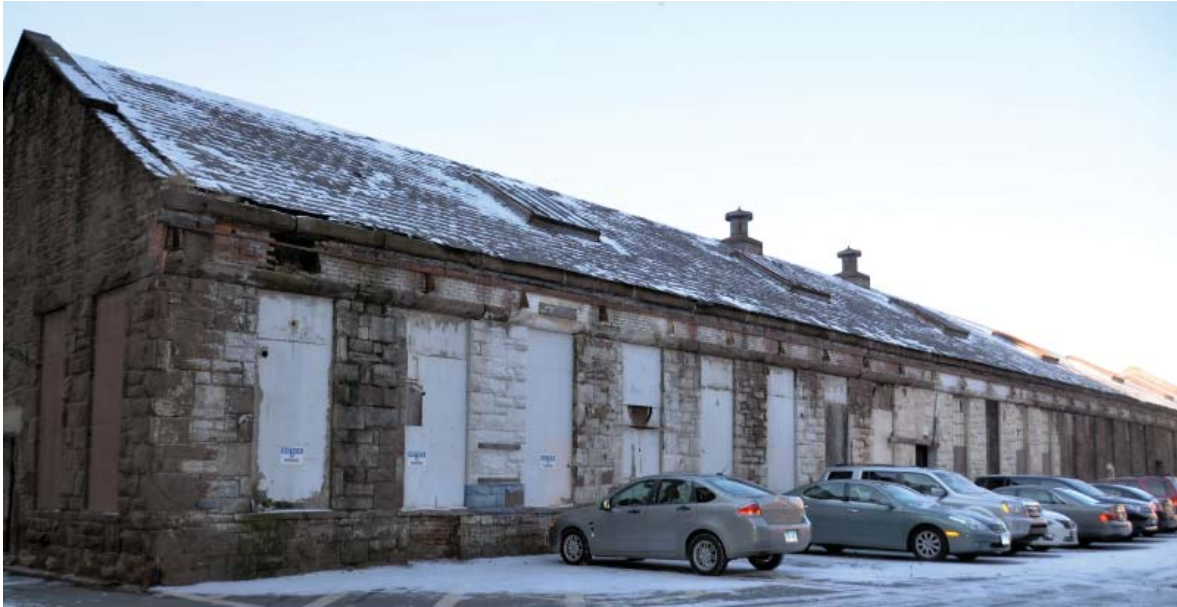
Figure 63. East elevation of Building 10 looking north. *An altered original doorway can be seen in bay 19 (ninth from the left).*

Most of the brownstone of which the piers and end walls were built remains, and it retains its rock face finish. It remains in least altered condition on the east elevations of both buildings (Fig. 62a), although the 13 south bays of the east elevation of Building 10 have been painted white (Fig. 63), and the brownstone of the east elevation of Building 8 shows the impact of shadow and damp in eroded and patched brownstone and deteriorated and missing mortar (Fig. 62b). At the west elevation of Building 8, the character of the wall has been altered by the addition of the raised concrete steam tunnel along its full length, which, except at the later doorway introduced at bay 9, completely obscures the masonry below the window sills and the relation of the building to grade. See figures 49a, 49b, 61 and 64. At the west elevation of Building 10, the piers defining bays 7 through 10 have been rebuilt in brick (Fig. 42a), as have the western bays 25 through 27 in Building 8 (Fig. 61). Also, what were once window openings elsewhere in the west elevation of Building 10 now read as masonry, since windows have been replaced with brick at bays 1 through 6 (Fig. 65), and with concrete block at bays 12 through 27 (Fig. 37). Generally, these infills are in better condition than the brownstone, although the masonry of bays 26 and 27 of the west elevation of Building 8 is in poor shape (Fig. 61).

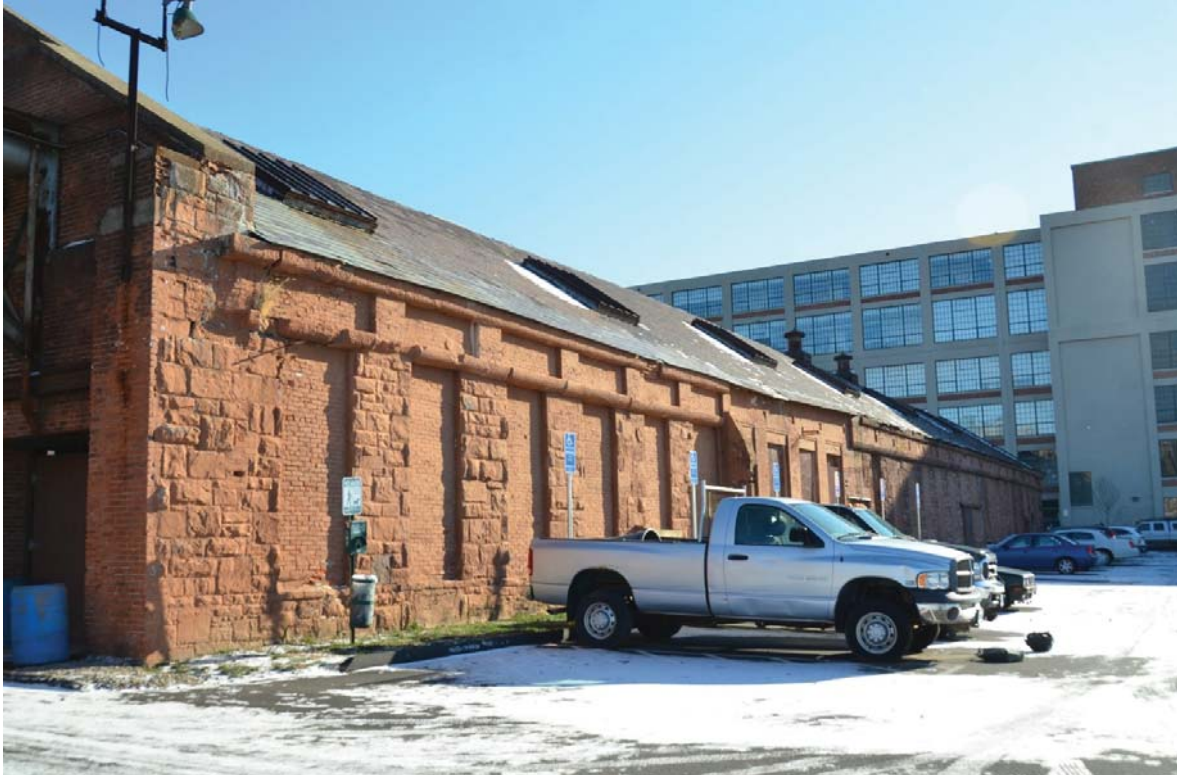
Figure 65. Building 10, west elevation. *Note the brick pilasters over the brownstone piers at bays 1 through 6, bays 7 through 10 rebuilt in brick, and the open beam pockets cut into the southern stretch of the frieze.*

At the east and west elevations too, the definition of the entablature as a frieze of brick between a brownstone architrave and cornice still remains clear. There has been local loss of brownstone units due to weathering, particularly at the higher course. At locations, just identified, where the piers have been rebuilt in brick, the brownstone elements of the entablature have been omitted (Figs. 61 and 65). The character of the frieze is now largely altered on all four elevations. Its original subdivision into pilasters and panels (see Appendix A, plate 5), which echoed the alternating sequence of triglyphs and metopes of the Doric order has disappeared except at bays 1 through 6 of the west elevation of Building 10. See figure 65 above. Clearly most of the brick of the friezes is not original. Further, the brick of the east and west friezes has been altered and damaged by the cutting pockets and placing beams for roofing over the spaces that had been created between Building 10 and buildings erected close to it at the time of World War I. These interventions are now represented by a series of holes in the west frieze and a series of beams ends left to rust in the east frieze. See figures 63 and 65.

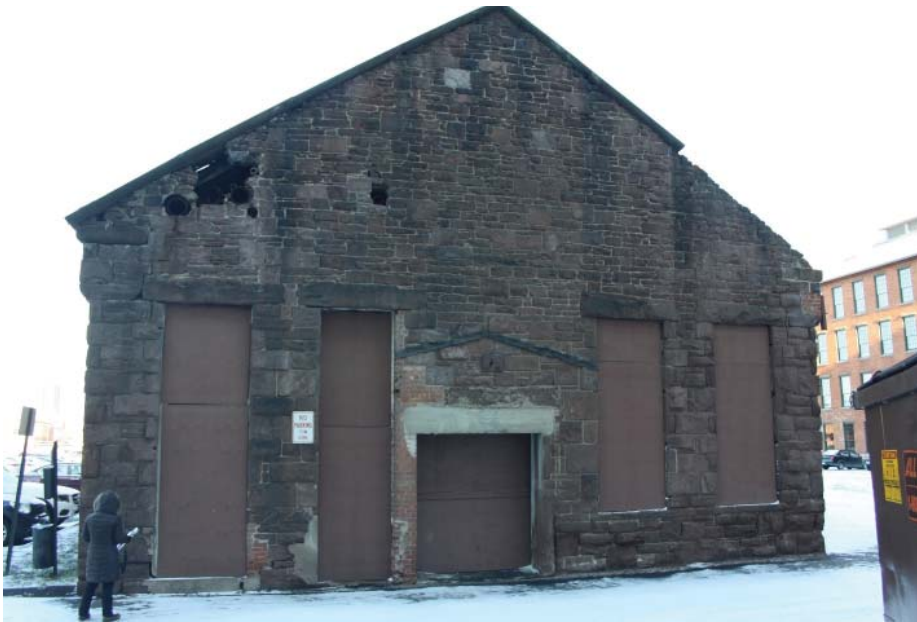
Figure 67. Building 10, south elevation.

The south elevation of Building 10 has undergone similar transformations. For a while, a passageway ran from its center to the South Armory, but only traces of mastic over the doorway tell its story. Since we have an early photograph of this elevation (Fig. 20), it is easy to see that the doorway was widened and provided with a concrete lintel. Like the other central doorways, the doorway was widened only in one direction, leaving the east jamb in place. Although all the original window openings still retain their original heads and jambs, the two to the west have been converted into doorways. A number of the original capstones are missing from the east gable, and some brownstone masonry is missing or damaged where holes have been cut for the steam pipes that served the South Armory.

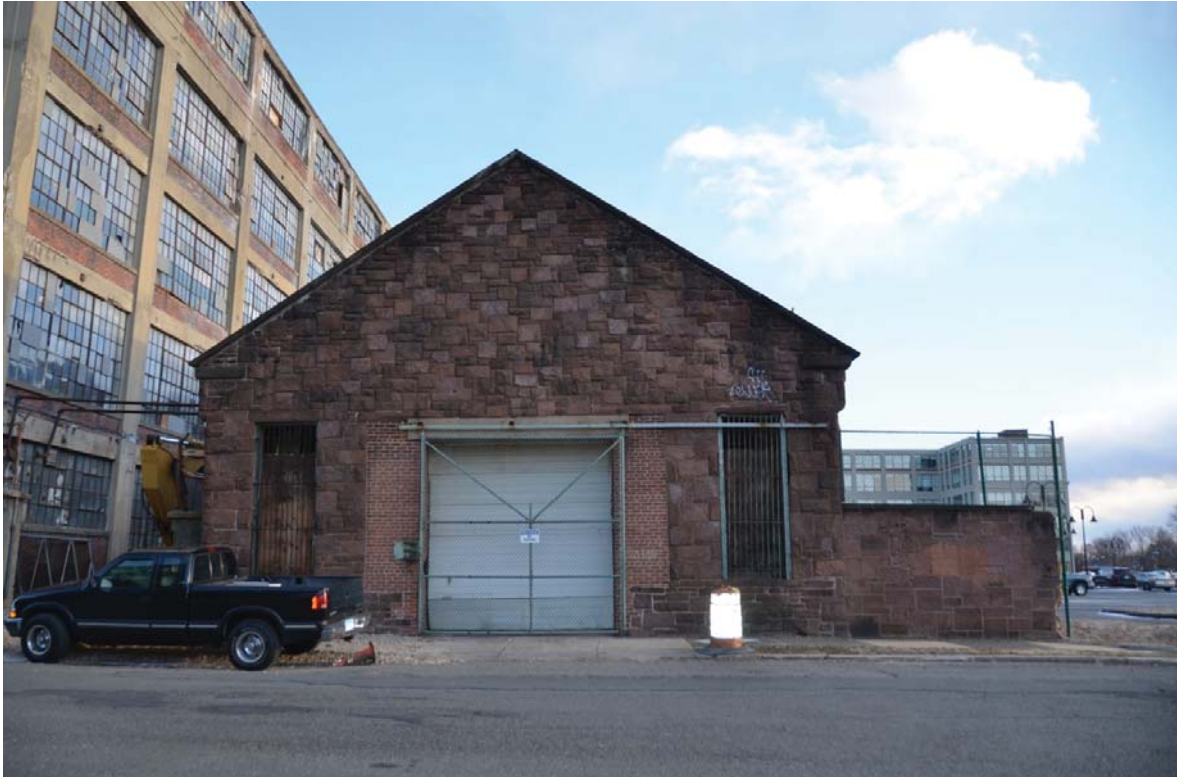
Figure 68a. Building 8, north elevation.

The north elevation of Building 8 retains more original character. See figure 68a which can be compared to the 1935 photograph of picketers protesting outside it (Fig. 7a). Again, the center doorway has been enlarged with a concrete lintel, and while both of the original jambs have been destroyed and the remainder of the window openings on either side have been bricked in, at least the doorway and the overall composition of the façade remains centered. The form of the outer window openings is uncompromised, original metal grilles remain in place, as do traces of the original wood window frames. The rest of the brownstone is intact and in fair condition and there is a full complement of stone caps.

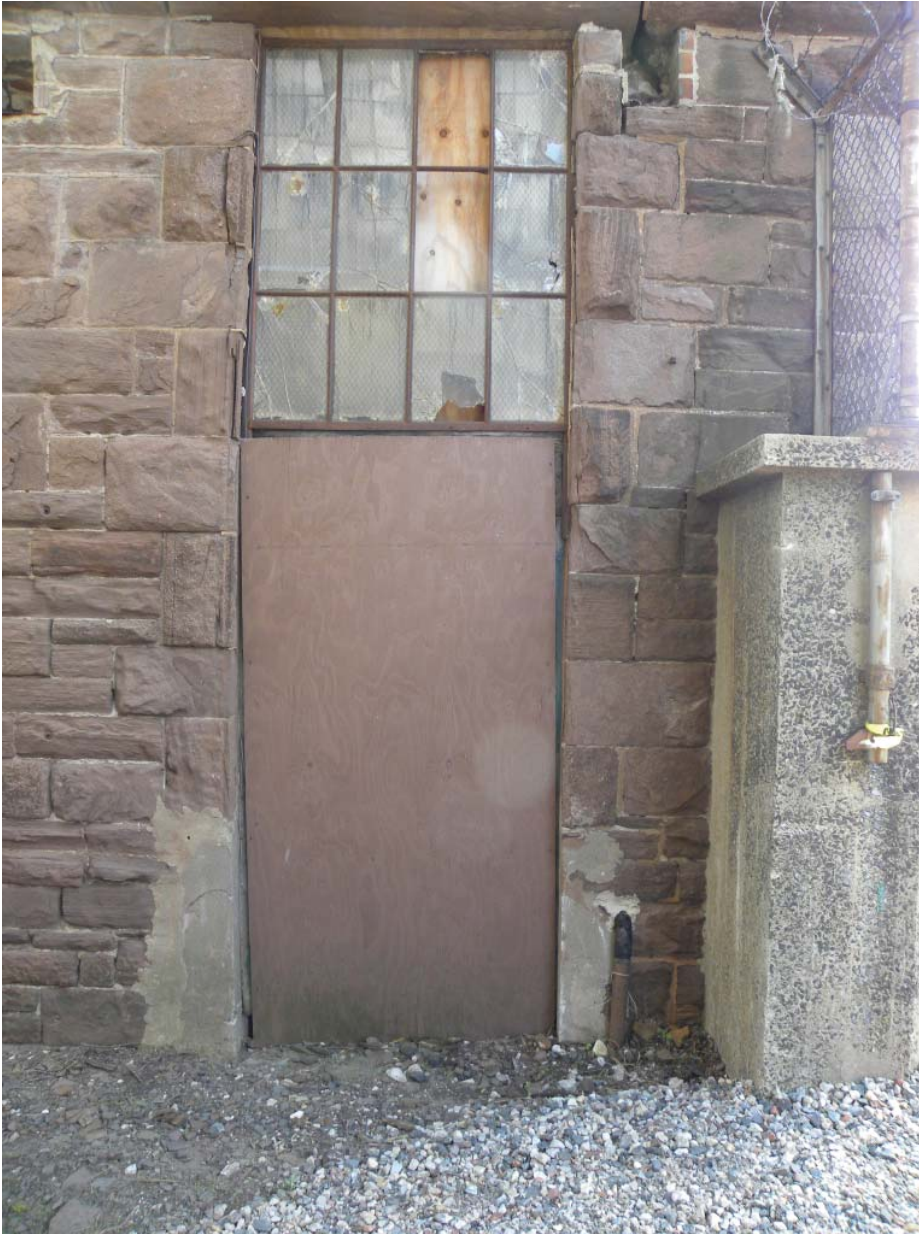
Figure 68b. Building 8, new doorway in east bay 1.

Unfortunately, the original organization of these two façades has been compromised by the widening of an original doorway (Building 10 bay 19), the creation of new doorways in original window bays (Building 8, bays 1 and 21-22, and Building 10, bay 12), and the infill of doorways (Building 8, bays 9 and 19). In addition, no original doors and frames remain. See figure 68a.

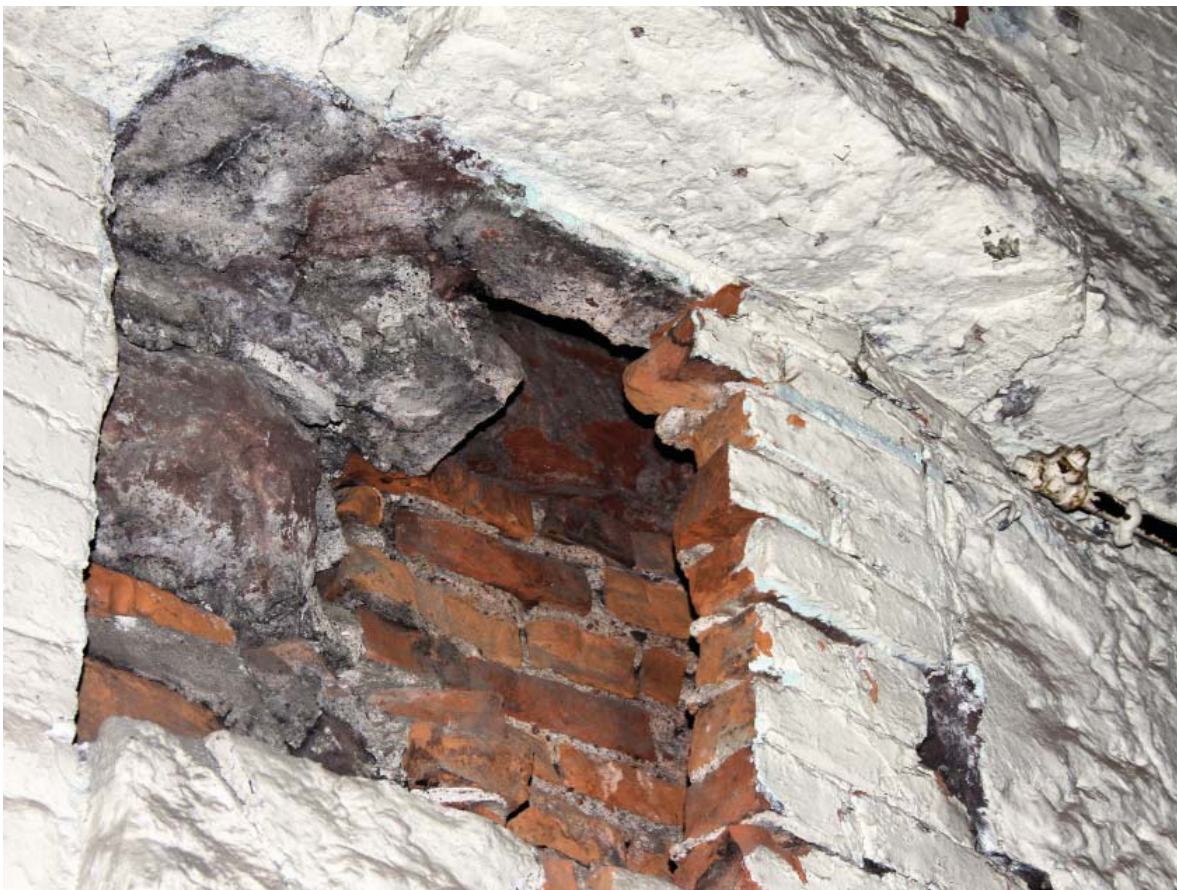
Figure 73. Masonry shaft with opening into masonry duct above.

Within the piers that support the entablature run unlined masonry shafts that connect to the horizontal masonry ducts through holes in the brownstone base of the ducts (Fig. 73). These shafts, typically about 6 by 14 inches, are built into every other pier in the long elevations of both buildings. They can be identified by the brick patches, filling holes that once allowed the heat and exhaust gasses from the hearths to pass into these shafts through flues built into chimney breasts immediately above the hearths. See figure 22 above and figure 74 below. These chimney breasts have long been demolished, but their form can be seen in and their connection to the shafts intuited from plate 7 of Appendix D and figure 27b above. It also seems, where there were lower openings through which air would have been supplied to the hearths, that the shafts descend below grade. See figure 23 above. The source of the input air was not able to be determined. All these shafts seemed to be in fair condition. Occasionally, deposits of sooty dust were found within them.

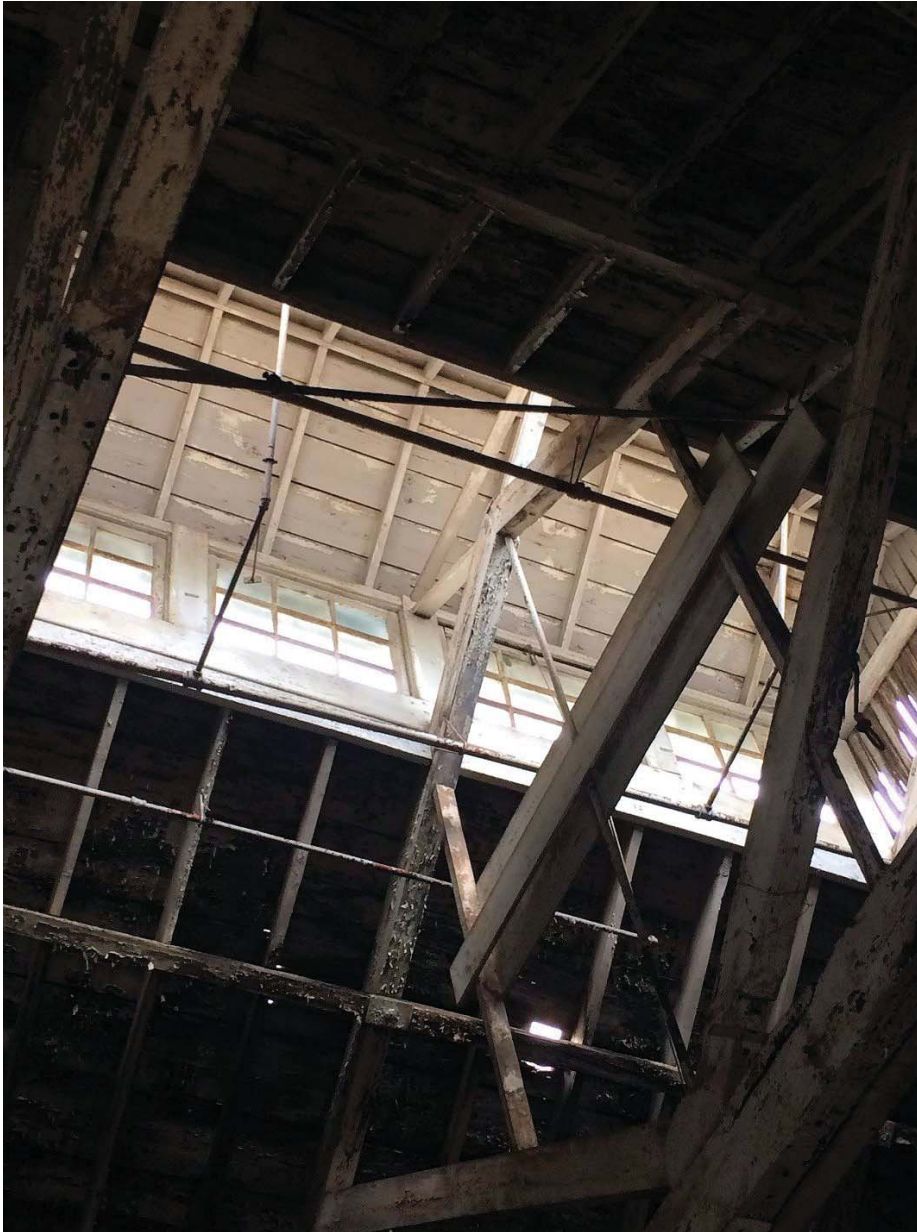
Figure 76. Building 8, central rooftop monitor.

At the center of Building 8 at the ridge one can see the wood framed monitor which is painted white like all the other timber components. The gabled roof construction appears to be in fair condition, but the vertical siding at its north and south ends has rotted and warped and is open. In the roof of Building 10 there are 12 flat, metal skylights, six on each slope, offset from one another. The frames seem sound, if rusted. Several glass lights are cracked, a few are broken and allow rainwater to fall freely into the building.
